Final Waterways Assets and Resources Survey Master Plan for Dredging and Beach Nourishment

For
Town of Dennis, Massachusetts

Prepared By:
Woods Hole Group, Inc.
81 Technology Park Drive
East Falmouth, MA 02536

November 2010

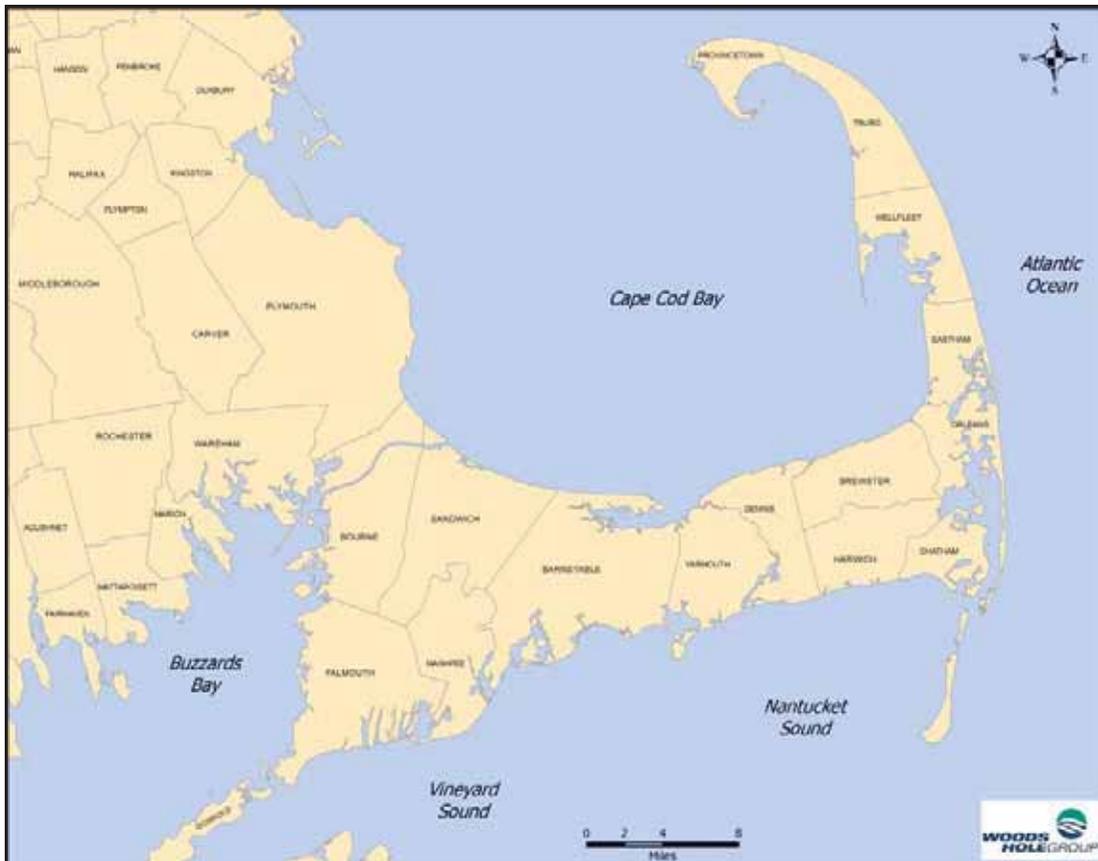
Figure 2-1. Extent of Dennis coastline bordering Cape Cod Bay to the North and Nantucket Sound to the South.

The Town of Dennis is located in central Cape Cod, and is bound to the north by Cape Cod Bay and to the south by Nantucket Sound. Its unique location on both of these water bodies creates over 63 miles of open coast and estuarine shoreline (Figure 2-1). The coastal waterways and beach systems that comprise the shorelines of Dennis serve as important resources to the town and its residents. The critical values of these resources must be maintained through careful management so that they continue to support their varied uses.

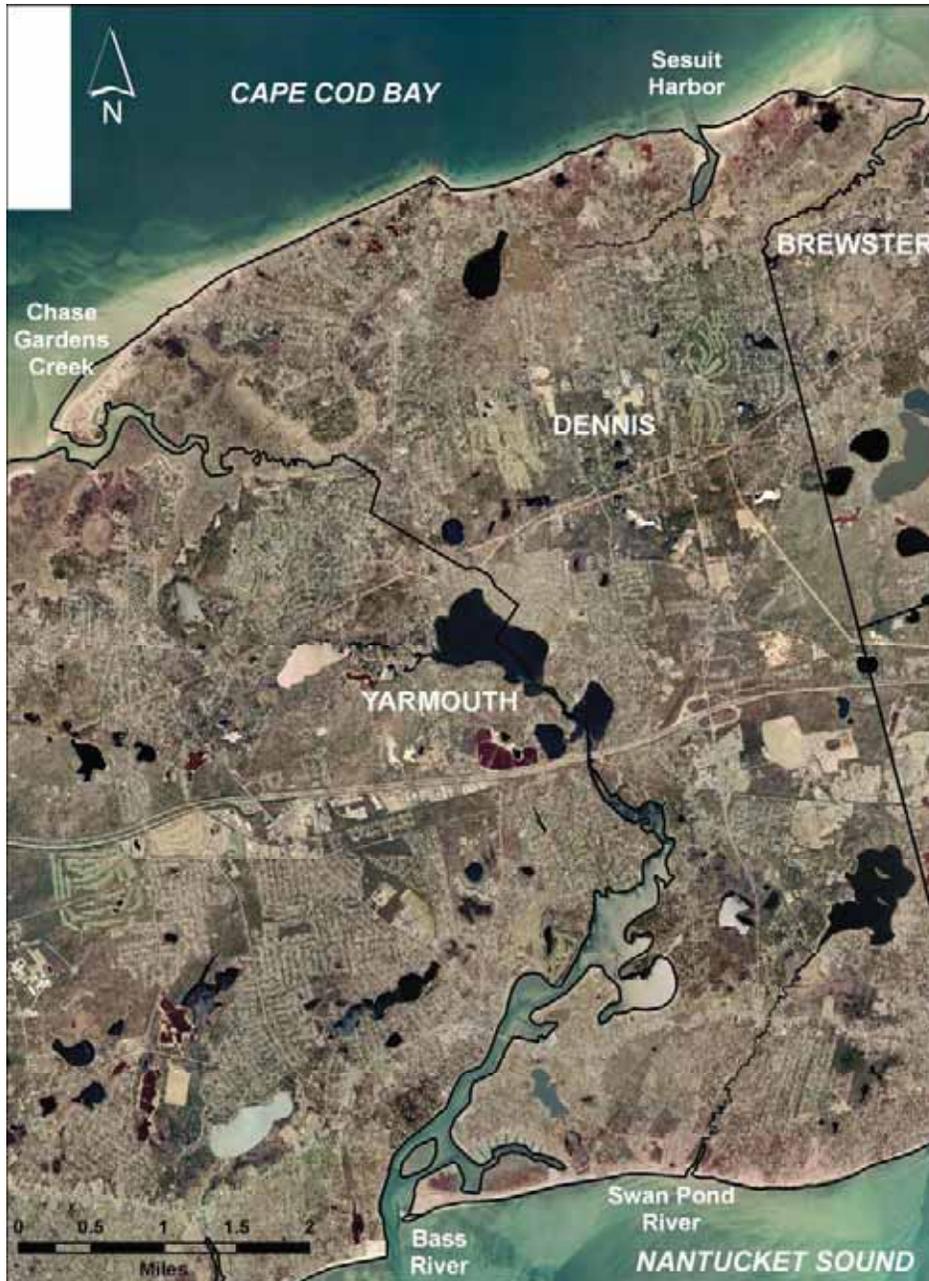
Figure 3-1. Distribution of Town of Dennis waterways resources.

The Town of Dennis has three primary waterways that are maintained through dredging. Sesuit Harbor, which is also a Federally-authorized navigation channel, is located on the north shore of Dennis along the Cape Cod Bay shoreline (Figure 3-1). The Bass River and Swan Pond River are both located on the Nantucket Sound shoreline, with portions of the Bass River being shared by the towns of Dennis and Yarmouth. Chase Garden Creek, or Bass Hole, located in the northwest part of Dennis, is a fourth waterway where the town would like to begin a program of maintenance dredging.

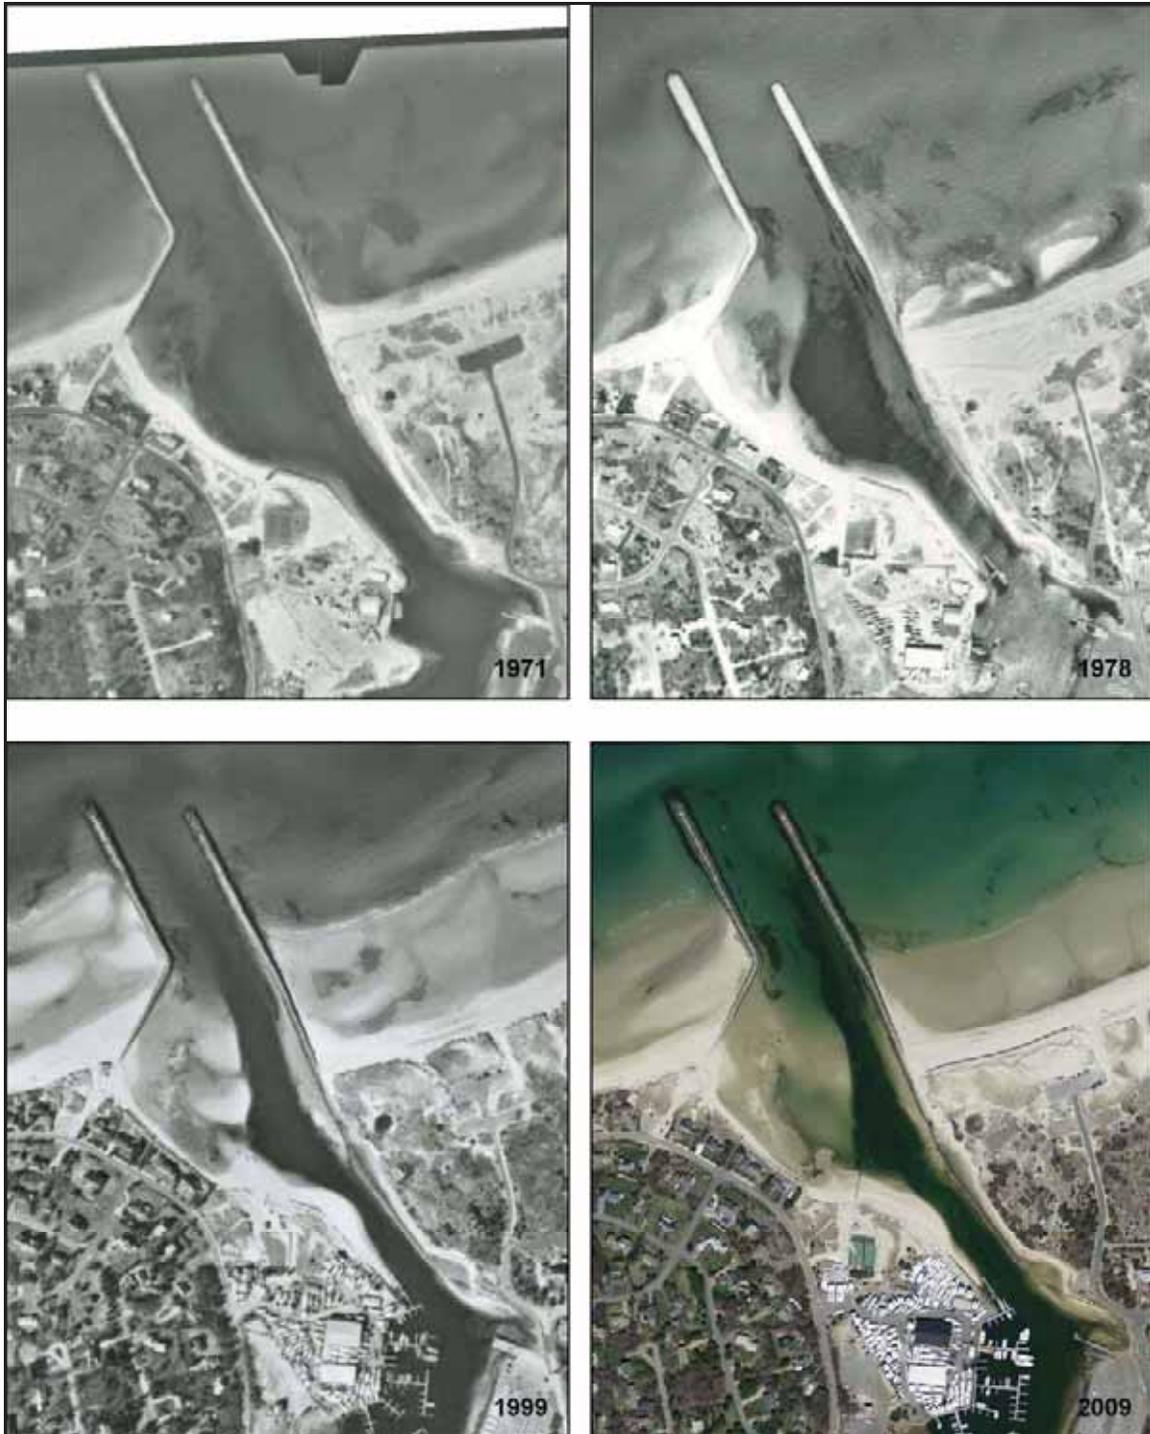
To maintain safe passage into Sesuit Harbor a program of maintenance dredging has been ongoing since the mid 1940s when the eastern jetty was constructed (Table 3-1). Massachusetts Division of Waterways initially dredged a narrow 30 ft wide channel and placed the dredged sand in the dunes east of the jetty (Figure 3-3). Several years later approximately 5,000 cubic yards of material were removed to form a turning basin near the existing boat ramp on the east side of the harbor. In 1958, a 100 ft wide channel was dredged to a depth of -8 ft MLW. In addition, the shoal area near the base of the western

Figure 3-2. Historical aerial photographs of Sesuit Harbor from 1971 to 2009 showing shoaling patterns.

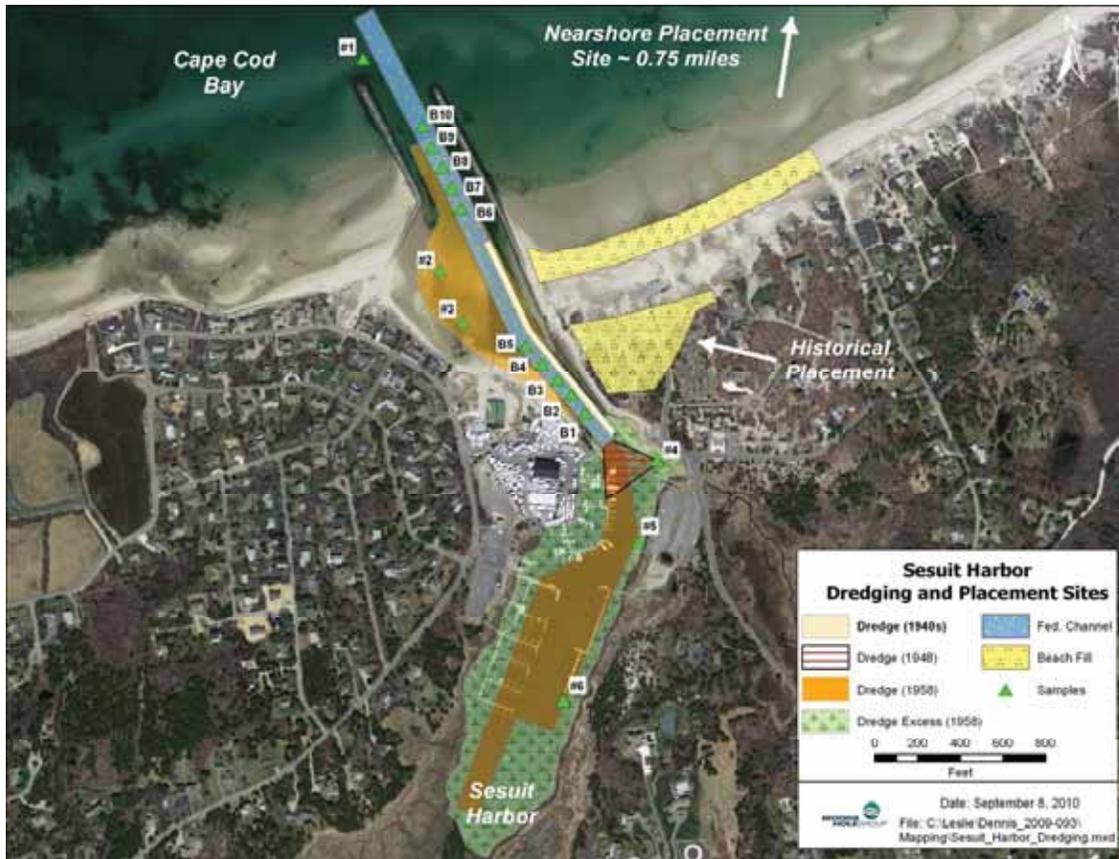
Figure 3-3. Sesuit Harbor dredging and placement activities.

jetty was dredged, as was the tidal marsh area where the current Town of Dennis marina facilities are located (Figure 3-3). Available data suggests that the 1958 dredging activities in the inner harbor area exceeded the permitted dredge footprint. Sediments from this large scale dredging effort were placed on Cold Storage Beach and on the marsh east of the inner harbor. The harbor channel was dredged again in 1976 by the Massachusetts Division of Waterways, and then starting in 1982 the existing federal navigation channel, which ranges from 100 to 80 ft wide, was dredged to a depth of -6 ft MLW. Over the next 23 years up until 2005, the US Army Corps of Engineers maintained the authorized channel a total of 13 times (Table 3-1). Dredged volumes

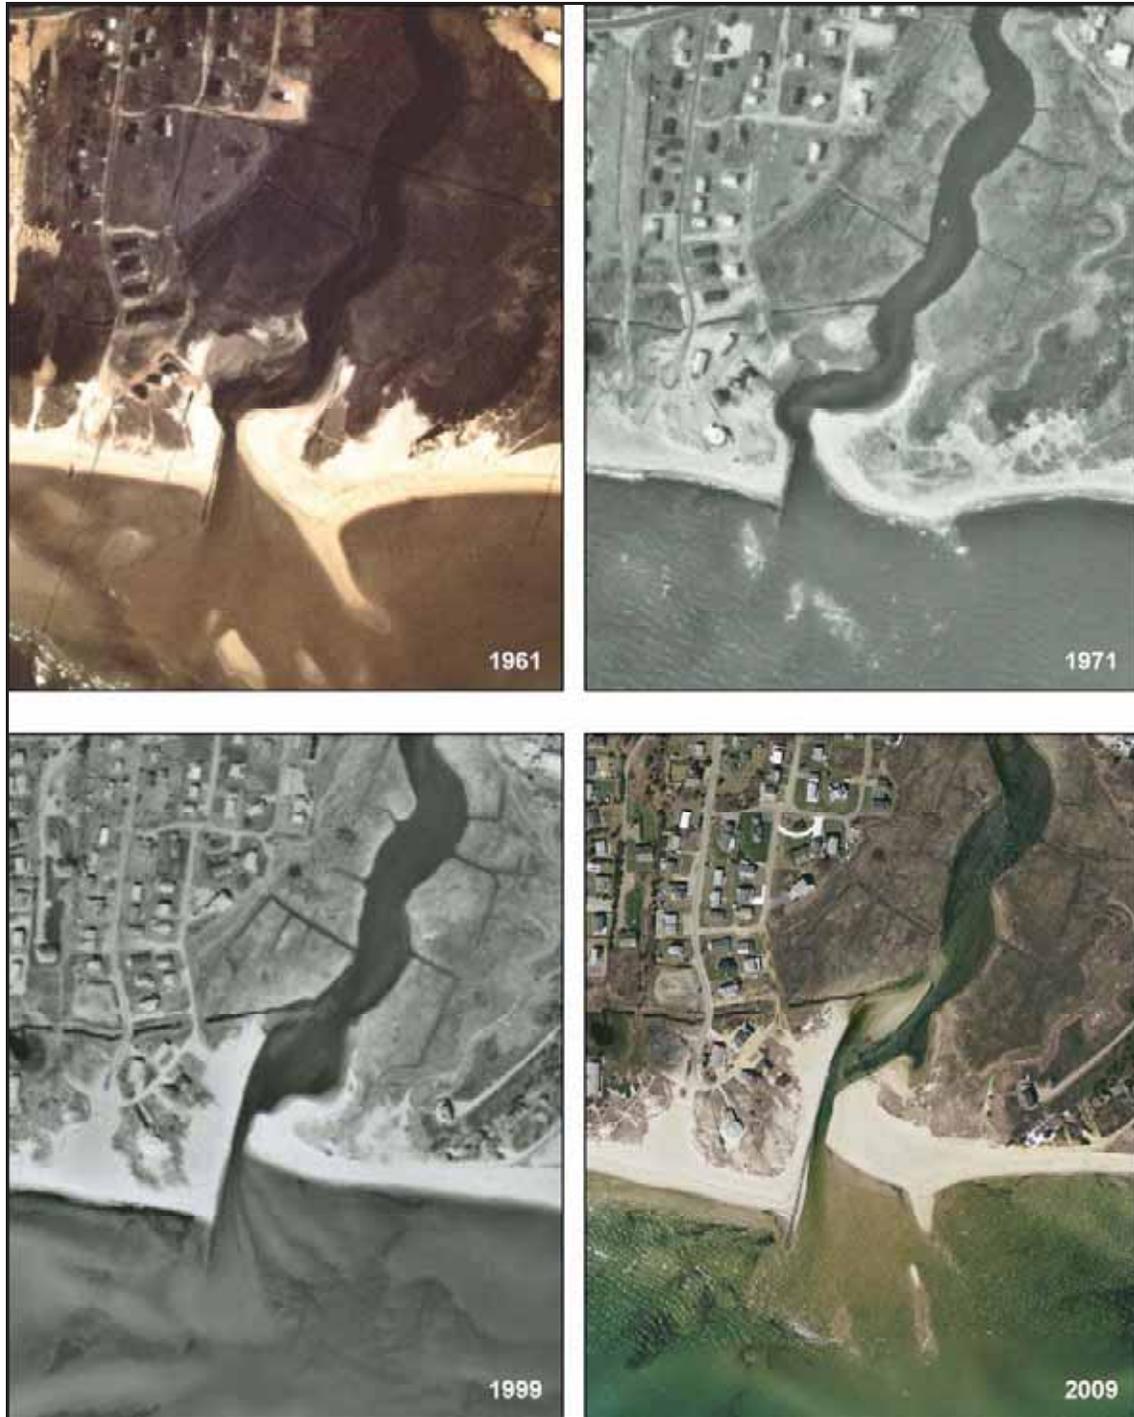
Historically, the entrance to Swan Pond River has been an area of active sediment transport (Figure 3-5). The location of the inlet was stabilized as early as 1850, when the western jetty was installed. Modifications to the jetty over the years have included lengthening in both directions, most recently in the early 1990s, when the jetty was extended in a northerly direction to prevent erosion of the western shoreline. Examination of historical aerial photos between and 1961 and 2009 show a net longshore transport direction from west to east in response to the prevailing wave direction out of the west (Figure 3-5). Sand moving in the littoral transport system bypasses the inlet through a mechanism called bar bypassing, where sediment is transported along the offshore shoals, or ebb-tidal delta. Sand also migrates into the channel from the shoreline along the eastern side of the inlet. This sand accumulates at the throat, or narrowest section of the channel, and also in the area of the flood-tidal delta immediately upstream of the throat. The combination of sand accumulating on the ebb- and flood-tidal shoals, and in the inlet throat, acts to restrict tidal flow into and out of the Swan Pond River.

Figure 3-5. Historical aerial photographs of Swan Pond River from 1961 to 2009 showing sediment transport patterns around the entrance to the river.

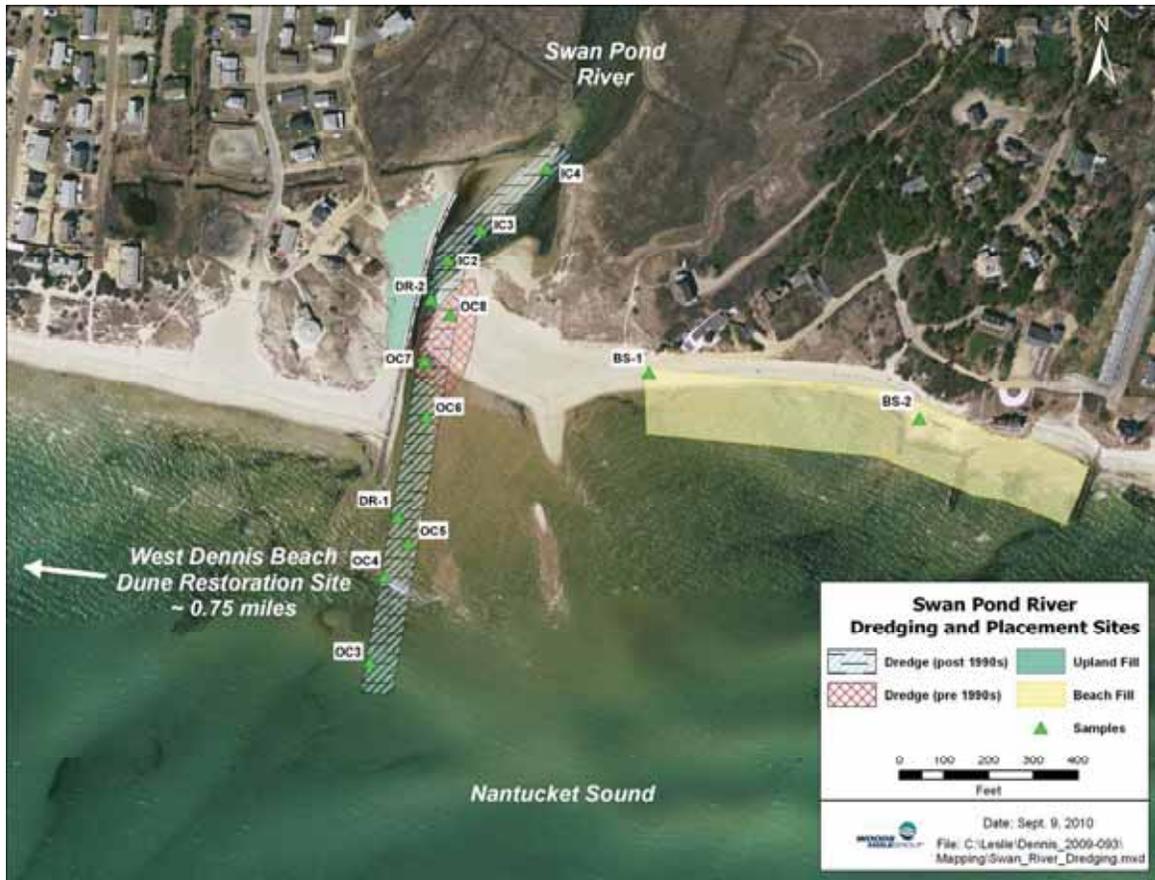
Figure 3-6. Swan Pond River dredging and placement activities.

To maintain adequate tidal circulation within the Swan Pond River, the Town of Dennis has undertaken a program of maintenance dredging (Table 3-3). The earliest record of dredging was in 1980, when approximately 17,000 cubic yards of sand were removed from the entrance channel. Since this period the entrance to the river has been dredged 6 times, with dredge intervals ranging from 1 to 10 years (Figure 3-6). The average

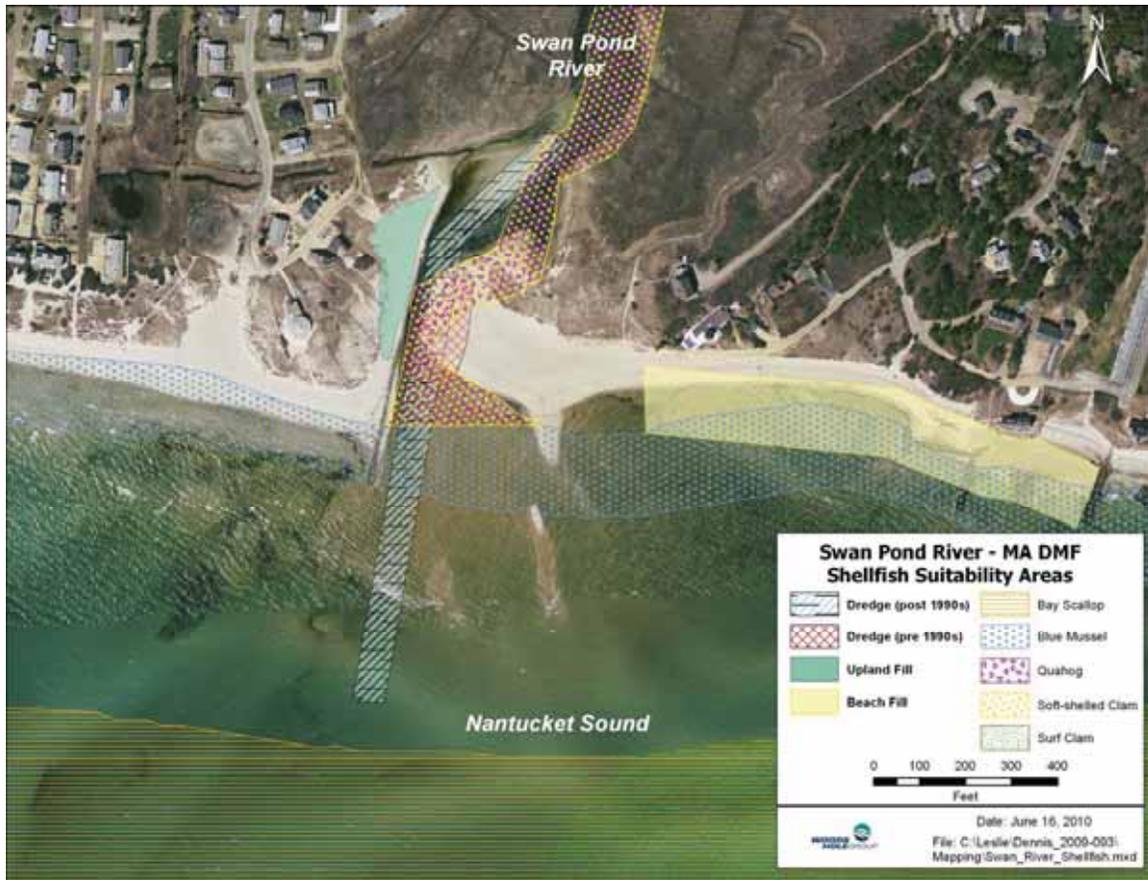
Figure 3-7. Swan Pond River shellfish resources.

Environmental resources in the Swan Pond River area are shown in Figures 3-7 through 3-9. Areas offshore of the site are shown by the Massachusetts Division of Marine Fisheries (DMF) to be potential habitat for bay scallops and surf clams, and the area along the entire shoreline is potential habitat for blue mussels. Quahog and soft-shelled clam habitat is mapped in the river starting at the inlet throat and extending upstream (Figure 3-7). Massachusetts DEP shows eelgrass resources immediately offshore of the permitted dredge footprint (Figure 3-8), and the Natural Heritage and Endangered Species Program shows the adjacent beaches and river as priority and estimated habitat for state-listed rare species (Figure 3-9).

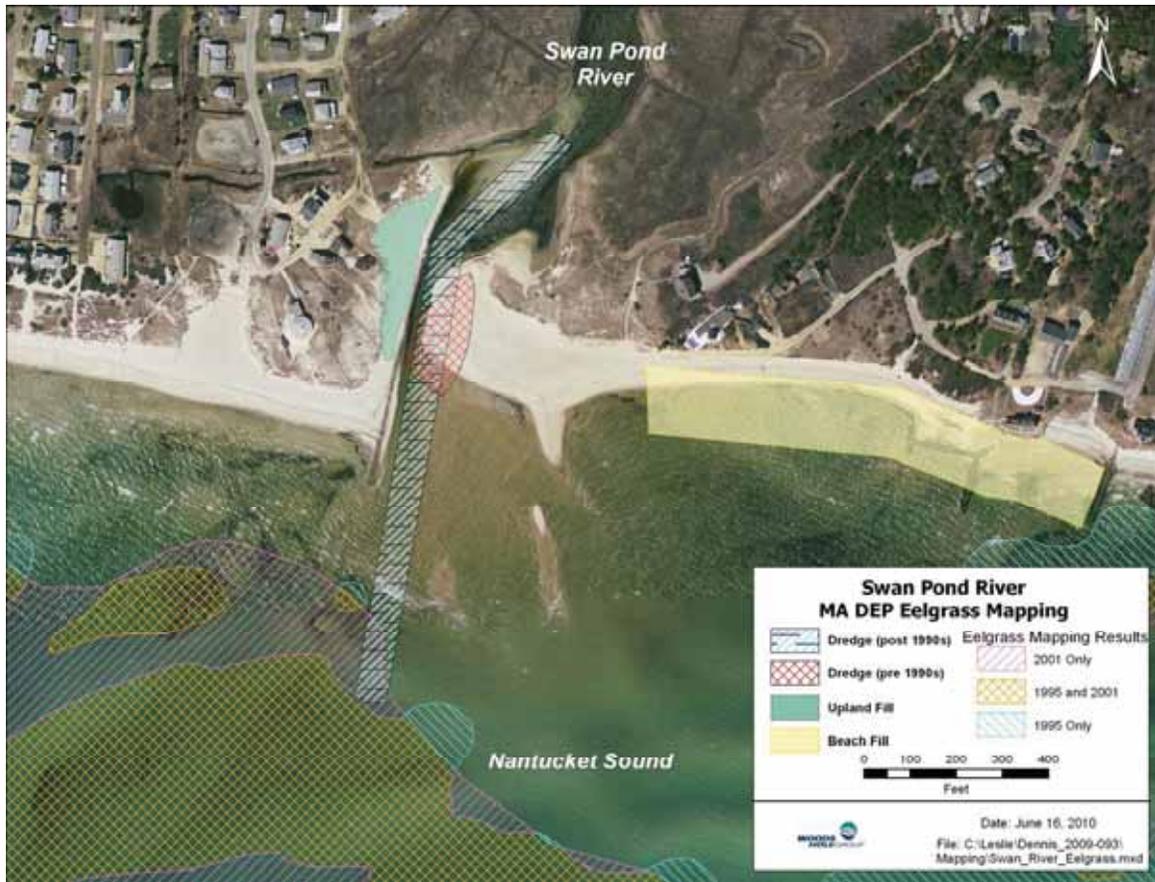
Figure 3-8. Swan Pond River eelgrass resources.

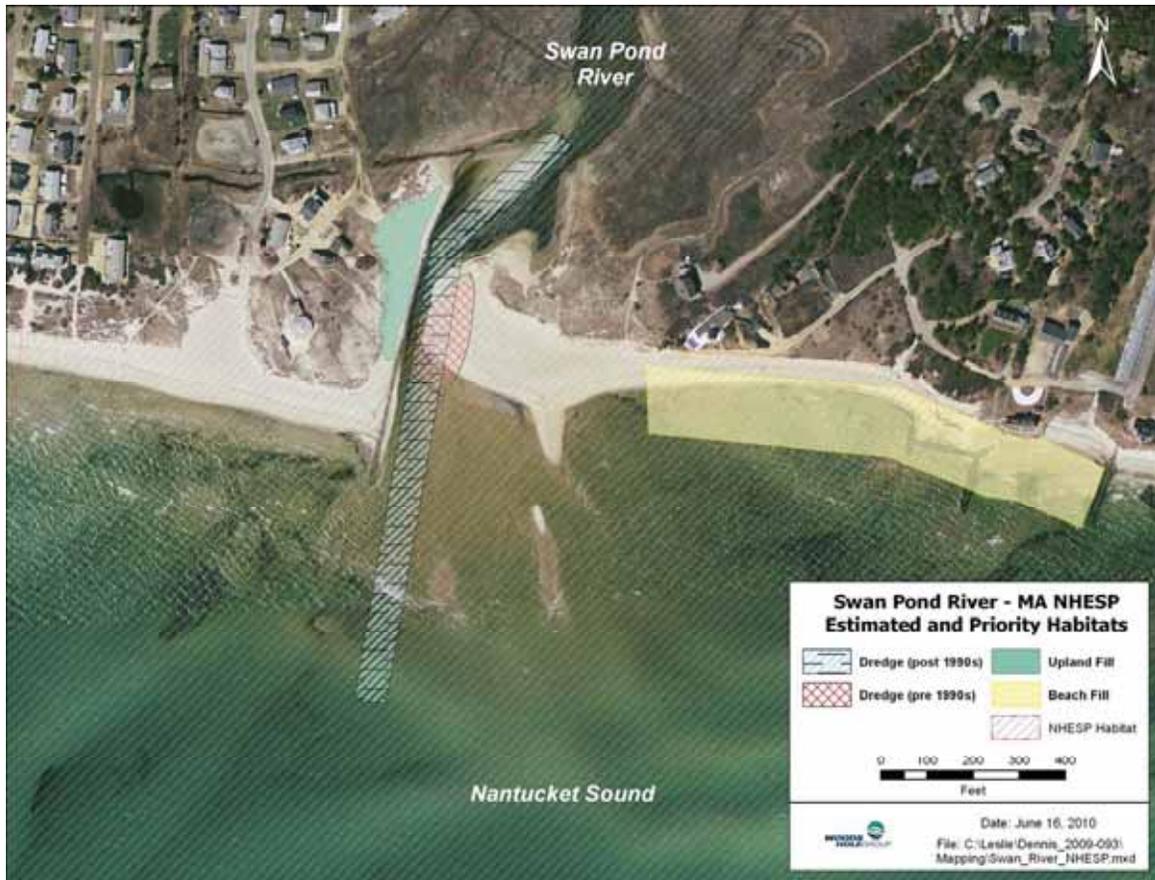
Figure 3-9. Swan Pond River NHESP estimated and priority habitat sites.

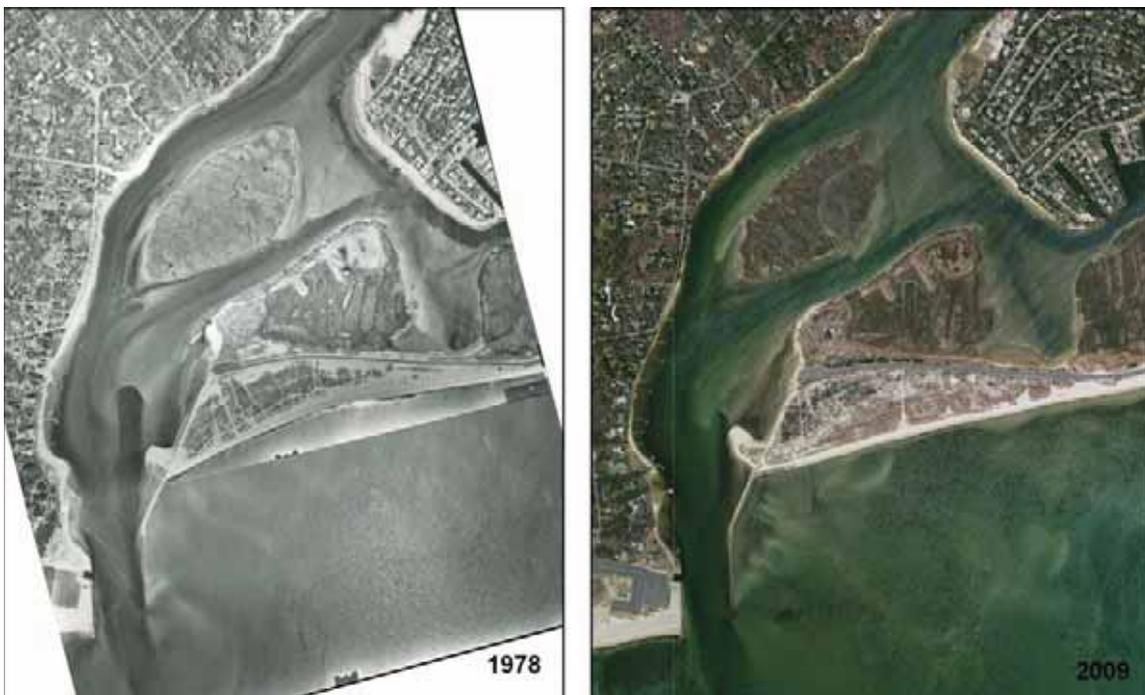
Figure 3-10. Historical aerial photographs of Bass River from 1978 to 2009 showing sediment transport patterns around the entrance.

Historically, changes in the geomorphology of the Bass River system have been relatively minor. Comparison of aerial photographs from 1978 to 2009 shows few changes in shoreline orientation within the estuary over the 31 year time period (Figure 3-10). One exception occurs at the western tip of West Dennis Beach, where a sandy spit has grown over the jetty, encroaching on the navigation channel. Other notable changes include a loss of salt marsh resource from Stage Island and areas to the north of West Dennis Beach (Figure 3-10).

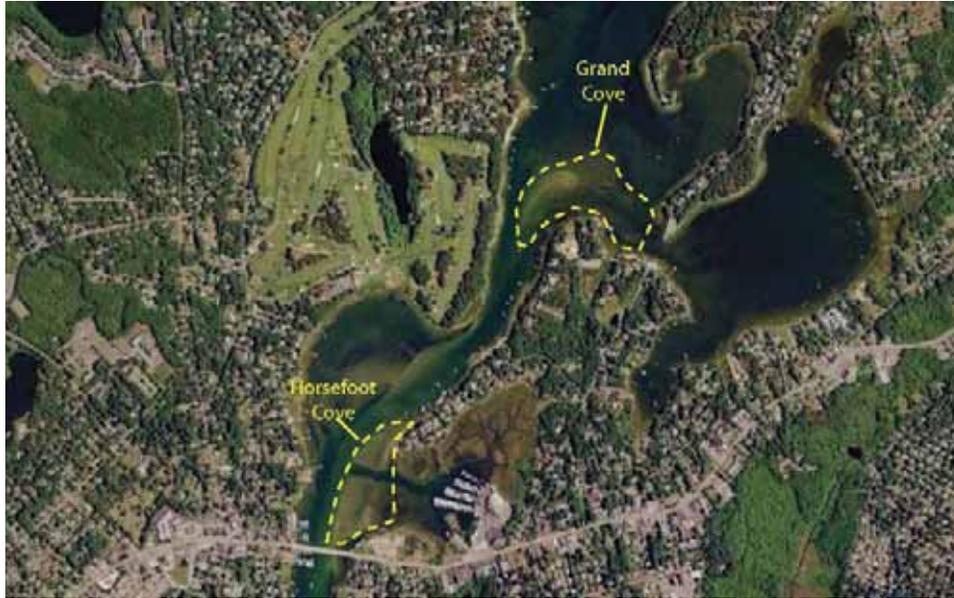
Figure 3-12. Bass River dredging and placement activities.

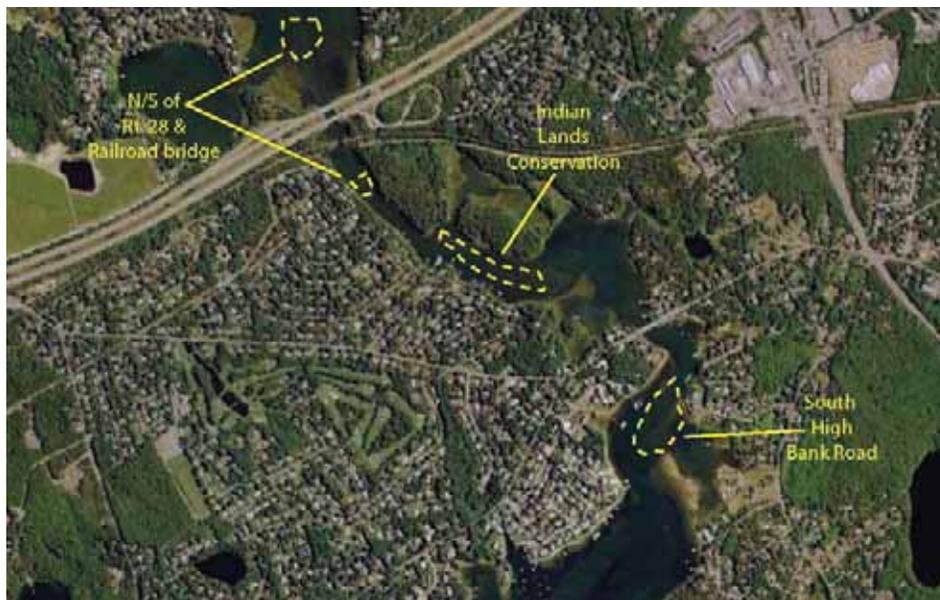
Figure 3-13. Bass River dredging and placement activities.

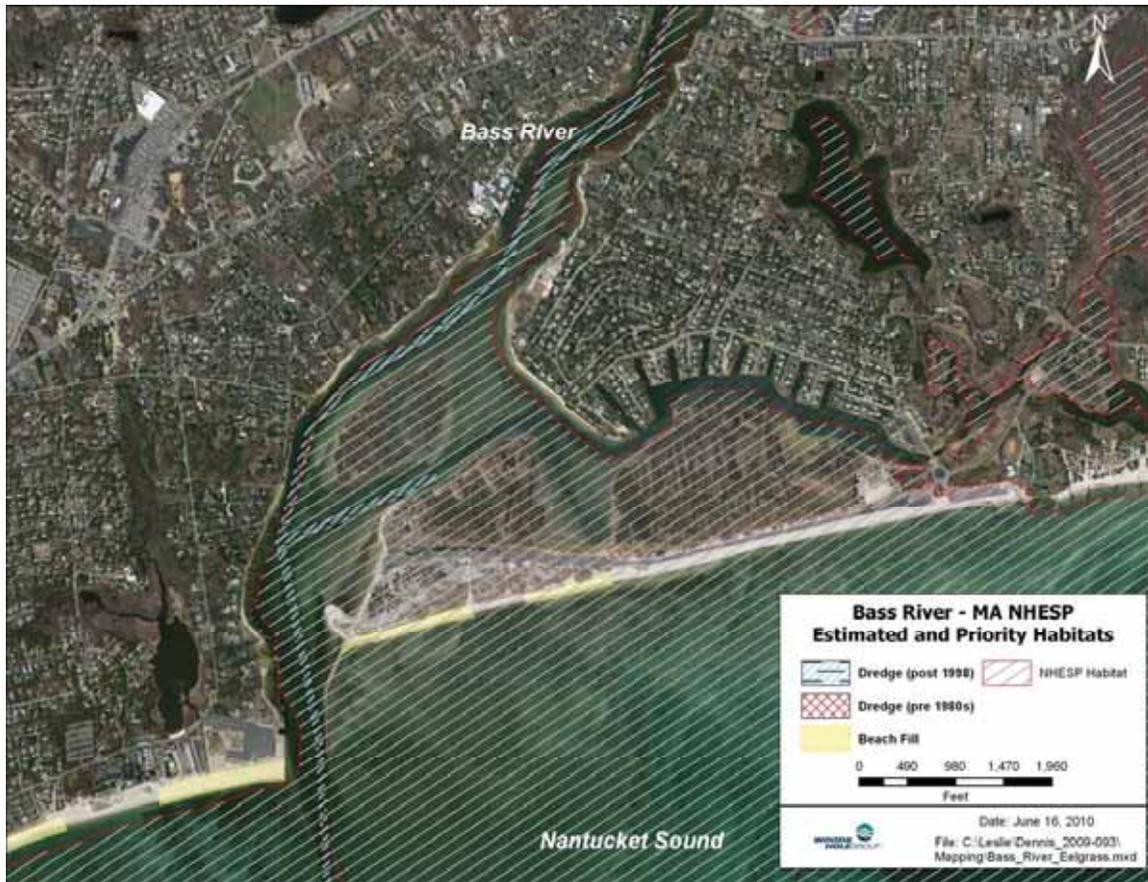
Figure 3-16. Bass River NHESP estimated and priority habitat sites.

Environmental resources in the Bass River area are shown in Figures 3-14 through 3-16. Areas offshore of West Dennis Beach are shown by the Massachusetts DMF to be potential habitat for bay scallops and surf clams. The inner portions of the river are habitat for a variety of shellfish resources; however, areas with the permitted dredge footprint are shown to be habitat for bay scallop, soft-shelled clam, quahog, and razor clams (Figure 3-14). Massachusetts DEP shows eelgrass resources in the areas offshore of the Bass River. They also indicate areas of former eelgrass inside the river on the shoals seaward of Stage Island (Figure 3-15). The Natural Heritage and Endangered Species Program also shows the entire Bass River and West Dennis Beach area as

priority and estimated habitat for state-listed rare species (Figure 3-16). The river is also an anadromous fish run for alewife and White Perch. Sediment samples collected from the Bass River dredge footprint in 1986 and 1994 show that the material is well-sorted coarse to medium-grained sand (Appendix A).

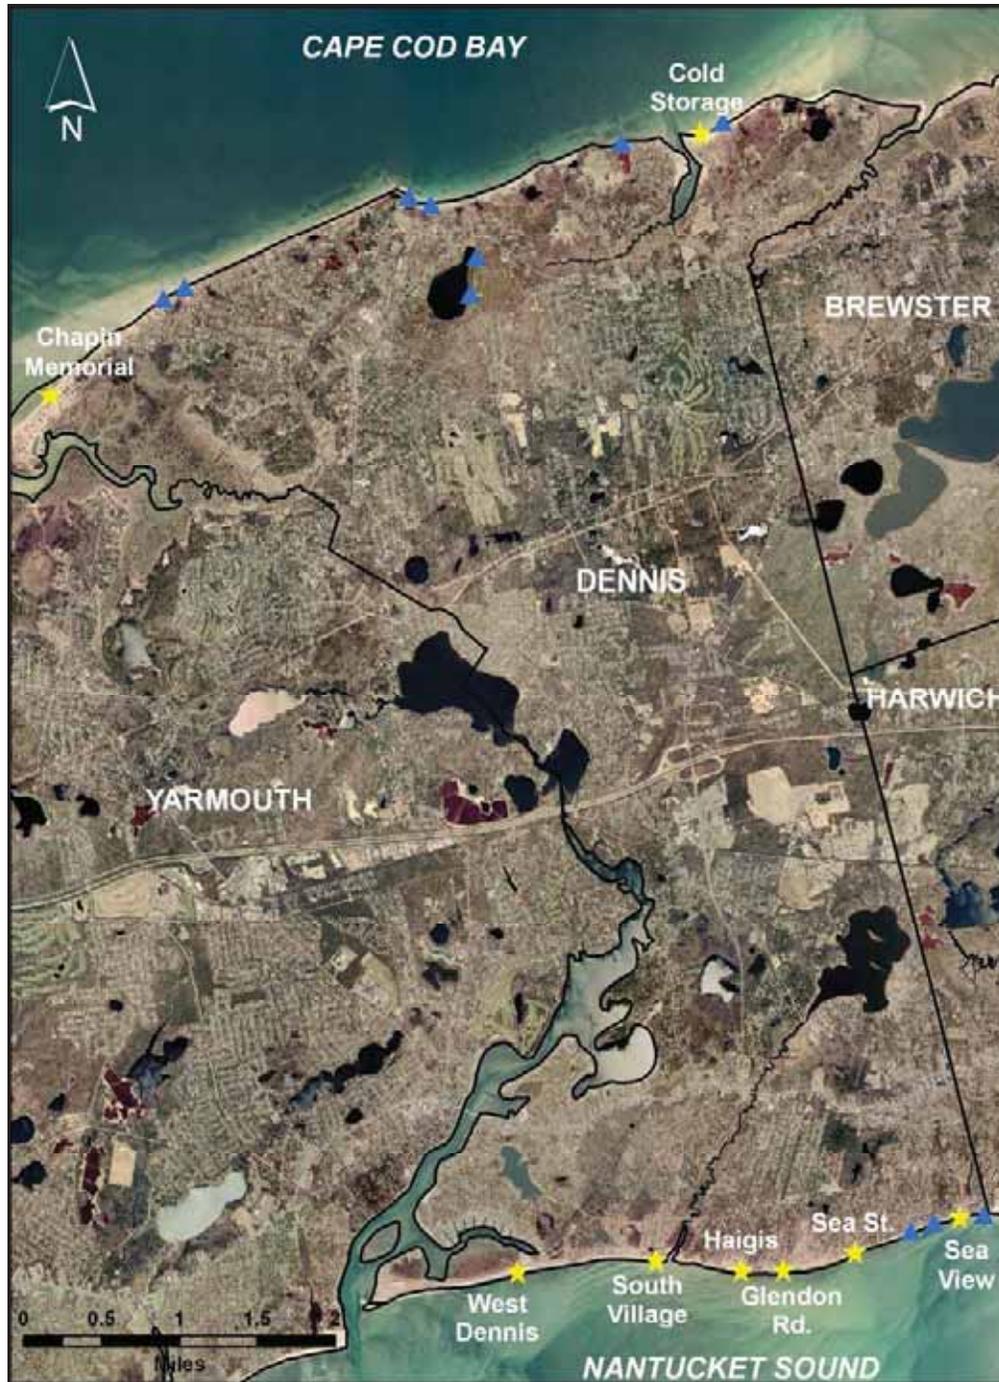
Figure 4-1. Distribution of public beach sites throughout the Town of Dennis (yellow stars – sites included in this study; blue triangles – other public beach sites).

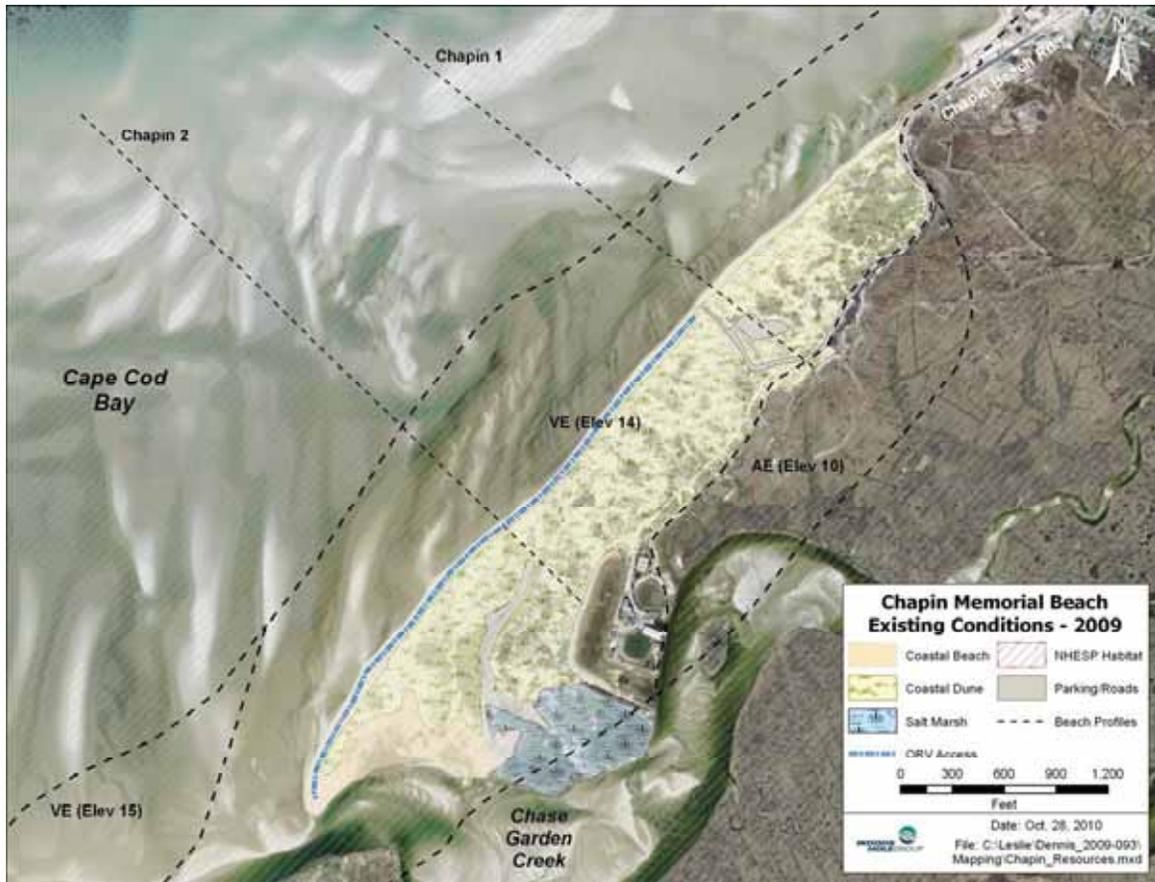
The public beach parcel at Chapin Memorial Beach is approximately 58 acres in size (Figure 4-2). The resource areas include Coastal Beach, Coastal Dune, Barrier Beach, and Salt Marsh. The Coastal Beach spans the entire length of the property, while the Coastal Dune encompasses the remaining areas of the parcel between the beach and the road. All areas of the beach are also considered Barrier Beach. The only Salt Marsh resource occurs at the terminus of the spit, adjacent to Chase Garden Creek. Most dune areas are well vegetated with beach grass, scrub pine, and other woody vegetation, although some bare dune spots do exist (Figure 4-3). Sediments on the beach are composed of medium-grained sand with a median particle size of 0.39 mm (Appendix A). During certain times of the year the tidal flats are also covered with a veneer of cobbles. The entire beach parcel is also mapped as Estimated and Priority Habitat by the

Figure 4-2. Existing conditions map of Chapin Memorial Beach.

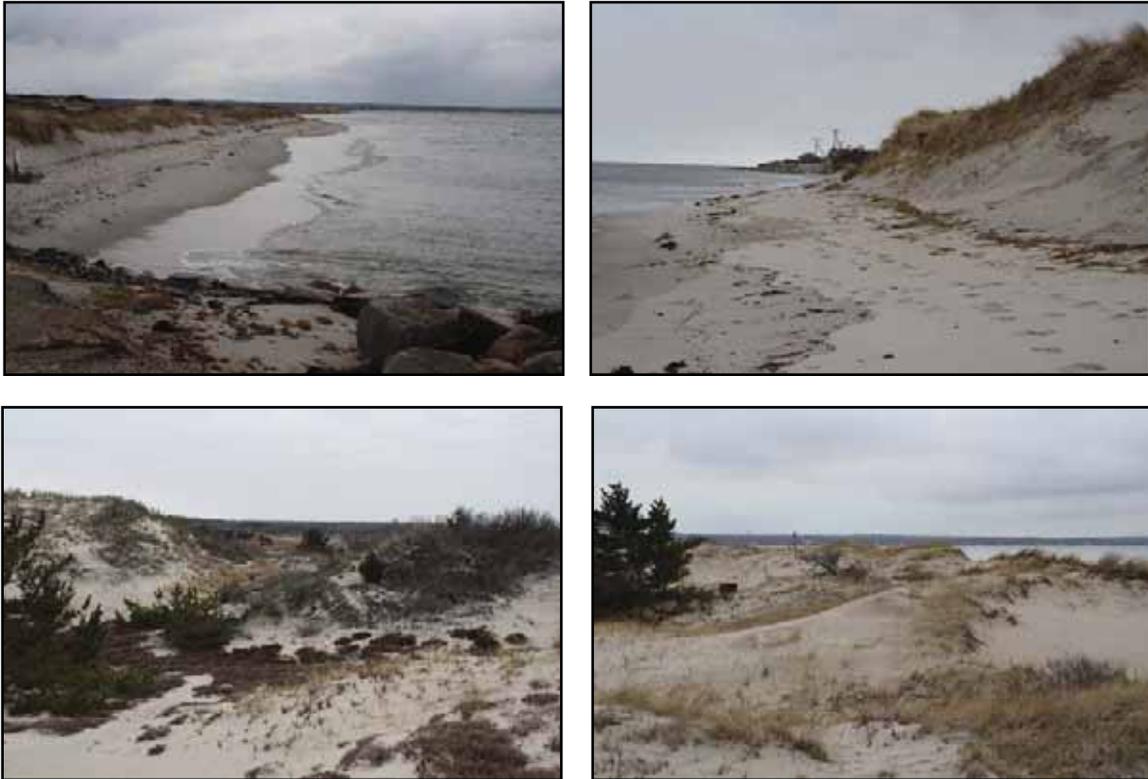
Figure 4-3. View of Chapin Memorial Beach showing the Coastal Beach resources looking to the southwest and northeast (top photos), as well the extensive Coastal Dune resources (bottom photos).

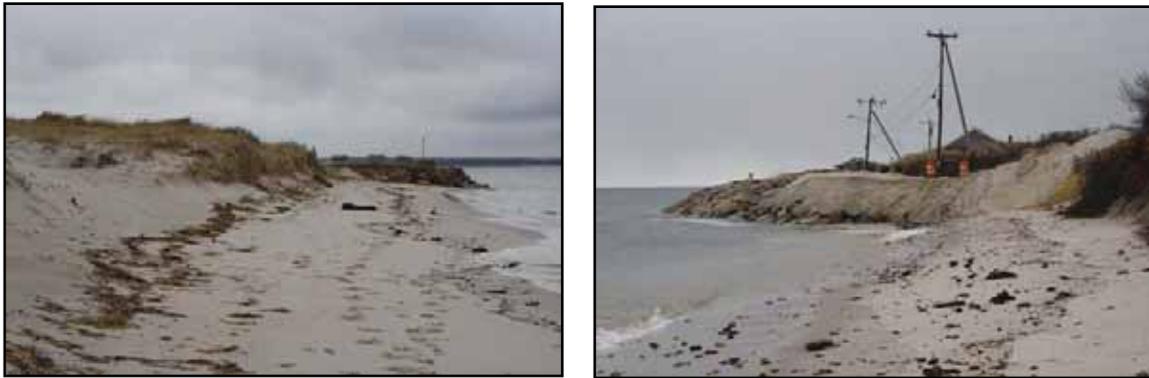
Figure 4-6. Areas of coastal armoring near the end of the road (left photo) and at the northeast boundary of Chapin Memorial Beach (right photo).

Since most of Chapin Beach has been maintained by the Town of Dennis as a natural undeveloped resource, few anthropogenic features exist. The public beach parking area and roadway are the two primary features, both of which are paved with asphalt. A small rip rap revetment has been installed at the end of the road where it meets the beach, to provide protection from erosion and to support a sand access ramp to the beach for ORV use (Figure 4-6). A second more extensive revetment is located at the northeast end of the beach, where Chapin Memorial Rd. (Dr. Bottero Rd.) is immediately adjacent to the beach. The revetment provides a critical measure of protection for the roadway which is in danger of being undermined by erosion. Historically, sand fill has been placed on the public beach parcel near the end of this revetment to provide emergency protection for the roadway.

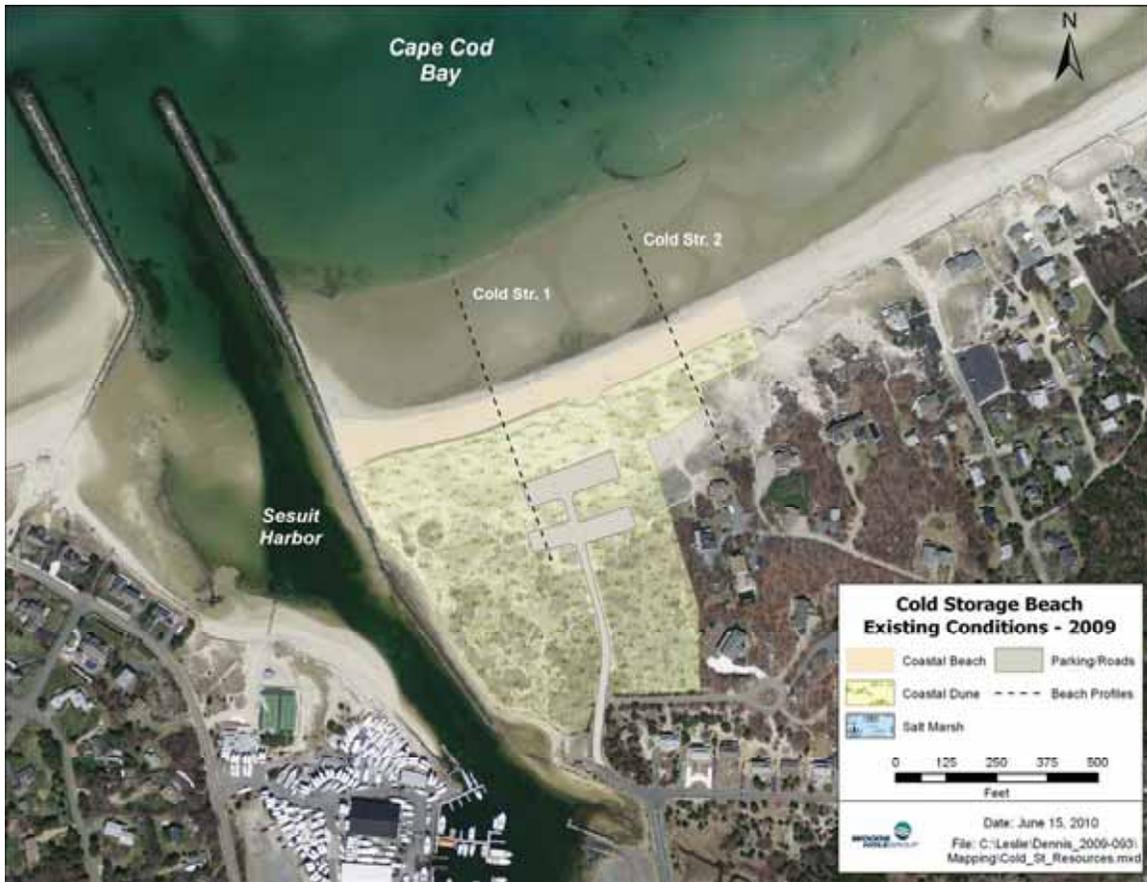
Figure 4-7. Existing conditions map of Cold Storage Beach.

The public beach parcel is approximately 15 acres in size, including both the beach and landward areas to the south where the parking lots are located (Figure 4-7). Coastal Beach and Coastal Dune resources comprise the majority of the parcel. The dune vegetation consists primarily of beach grass, with woody species of beach plum, bayberry, and scrub pine across the landward half of the dune (Figure 4-8). Sediments on the beach are composed of medium-grained sand with a median particle size of 0.46 mm (Appendix A). In general, these medium-grained sands are uniformly distributed across the beach; however, gravel covered beach cusps commonly form in the intertidal zone during the winter season. State/Federal listed rare species are not present on Cold Storage Beach.

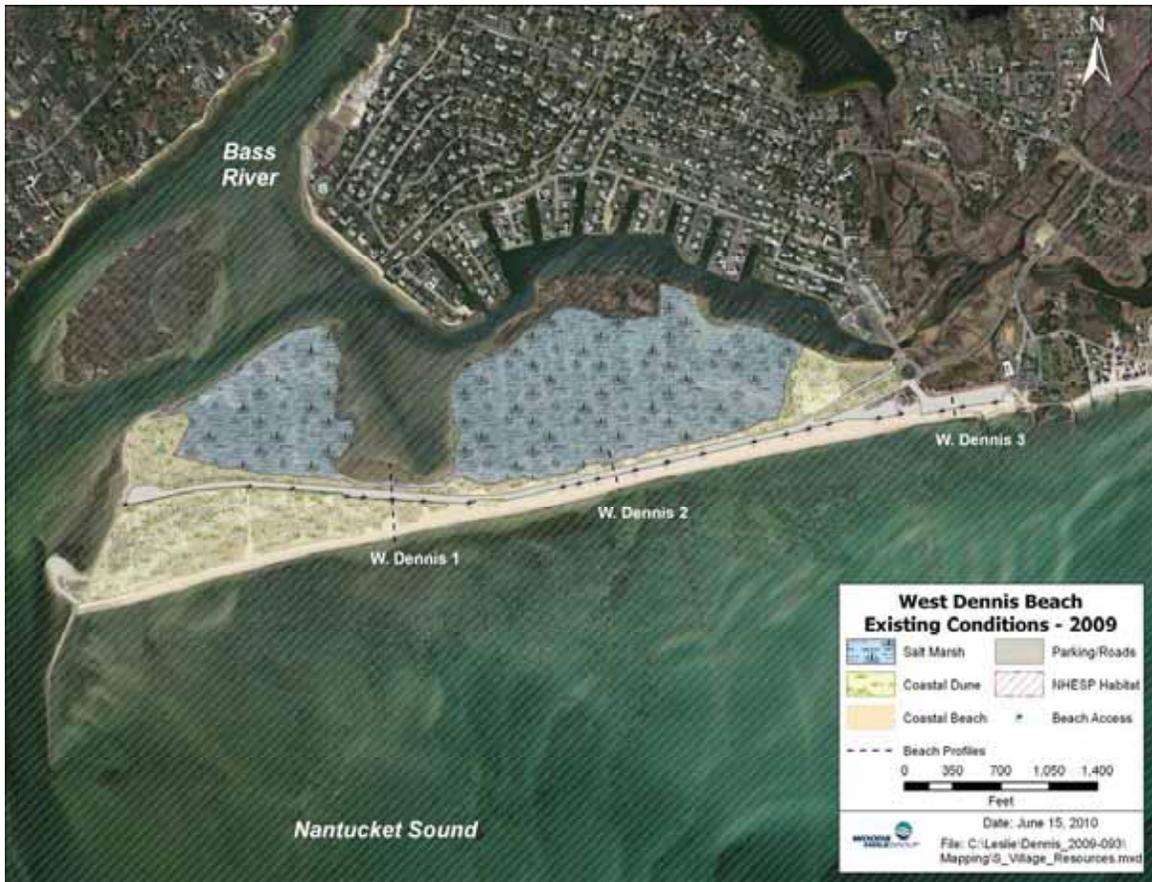
Figure 4-11. Existing conditions map of West Dennis Beach.

West Dennis Beach extends in an east-west direction for more than 1 mile and the property is approximately 165 acres in size. Wetland resources include Coastal Beach, Coastal Dune, and extensive areas of Salt Marsh (Figure 4-11). The area is also considered to be a Barrier Beach resource. The Coastal Dunes are located on both sides of the access road and are vegetated primarily with beach grass, *Rosa Rugosa* and Beach Plum (Figure 4-12). A number of footpaths have been established across the dunes by beachgoers traveling from the parking area to the beach. Sediments on the beach are composed of medium- to fine-grained sands with a median particle size of 0.33 mm (Appendix A). The Massachusetts NHESP has mapped the West Dennis Beach area as Estimated and Priority habitat for rare or state-listed rare wildlife (13th Atlas, 2008; Figure 4-11). Consequently, the Town of Dennis performs annual monitoring to document nest locations, and to protect the shorebirds. Data from 2007-2009 show that Piping Plovers and Least Terns have nested in the beach and dune areas at the western end of the beach.

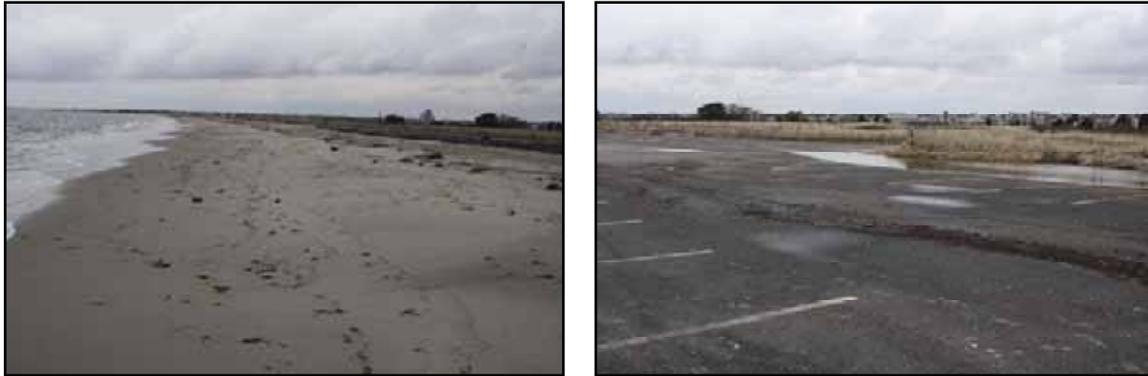
Figure 4-12. View of beach area, parking lot, and low lying coastal dunes at West Dennis Beach (views looking to the west).
