Final Waterways Assets and Resources Survey Master Plan for Dredging and Beach Nourishment

For
Town of Dennis, Massachusetts

Prepared By:
Woods Hole Group, Inc.
81 Technology Park Drive
East Falmouth, MA 02536

November 2010

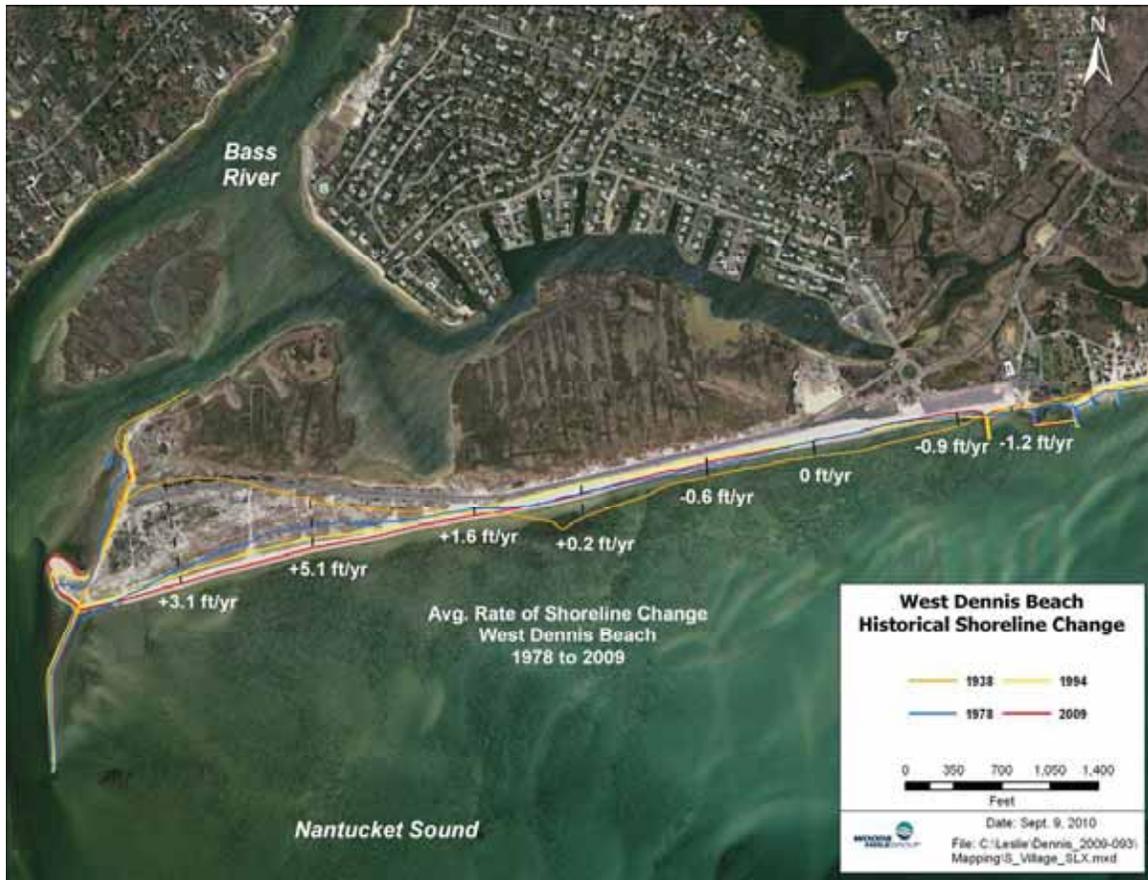
Figure 4-14. Historical shoreline change from 1938 to 2009 for the West Dennis Beach area.

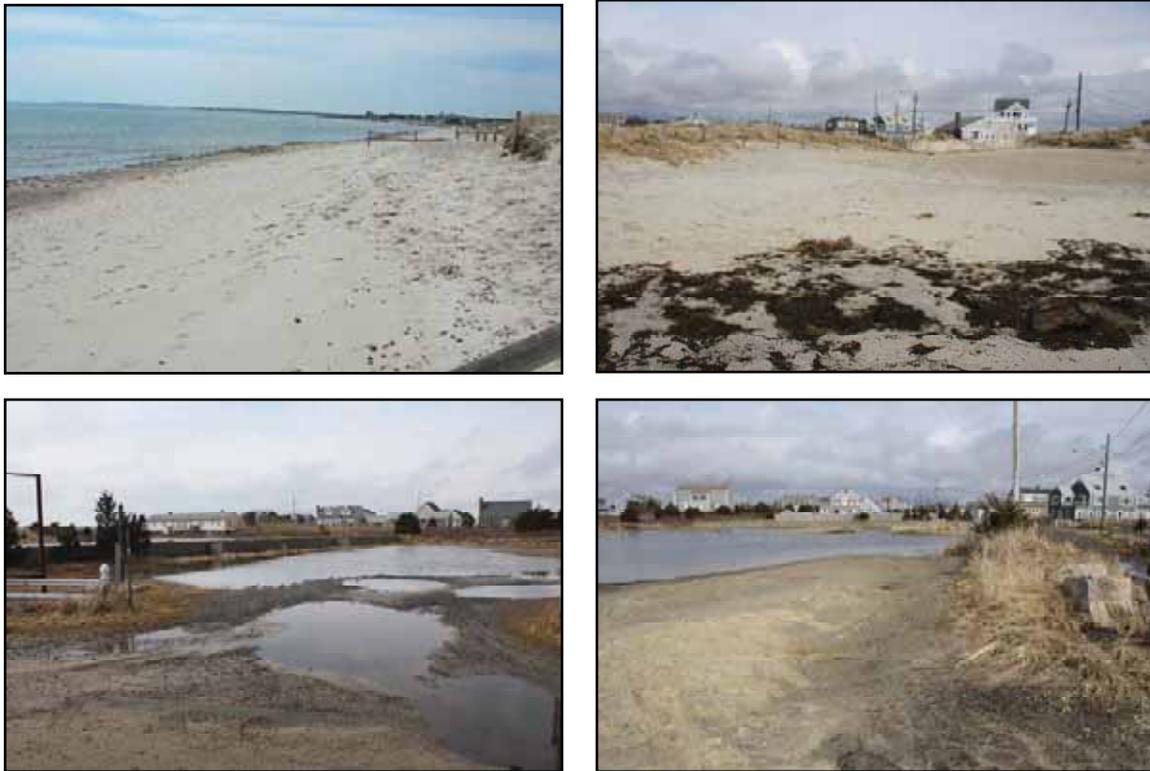
Access paths to the beach have been worn down to the same elevation as the high tide beach, and therefore provide little protection from flooding to more landward areas during storms. FEMA's predicted elevation of 4.9 ft NAVD88 for stillwater flooding during a 10-yr storm indicates that much of the parcel will be inundated during a 10-yr storm and greater. According to the proposed FEMA FIRMs, the beach and dune areas of the lot fall within a mapped VE-zone with a BFE of 14 ft NAVD88. The FIRMs show an AE-zone with a BFE of 10 ft NAVD88 in the parking areas landward of the dunes (Figure 4-15).

Figure 4-16. View of South Village beach (left photo) and coastal dunes (right photo), and parking areas flooded by recent storm activity.

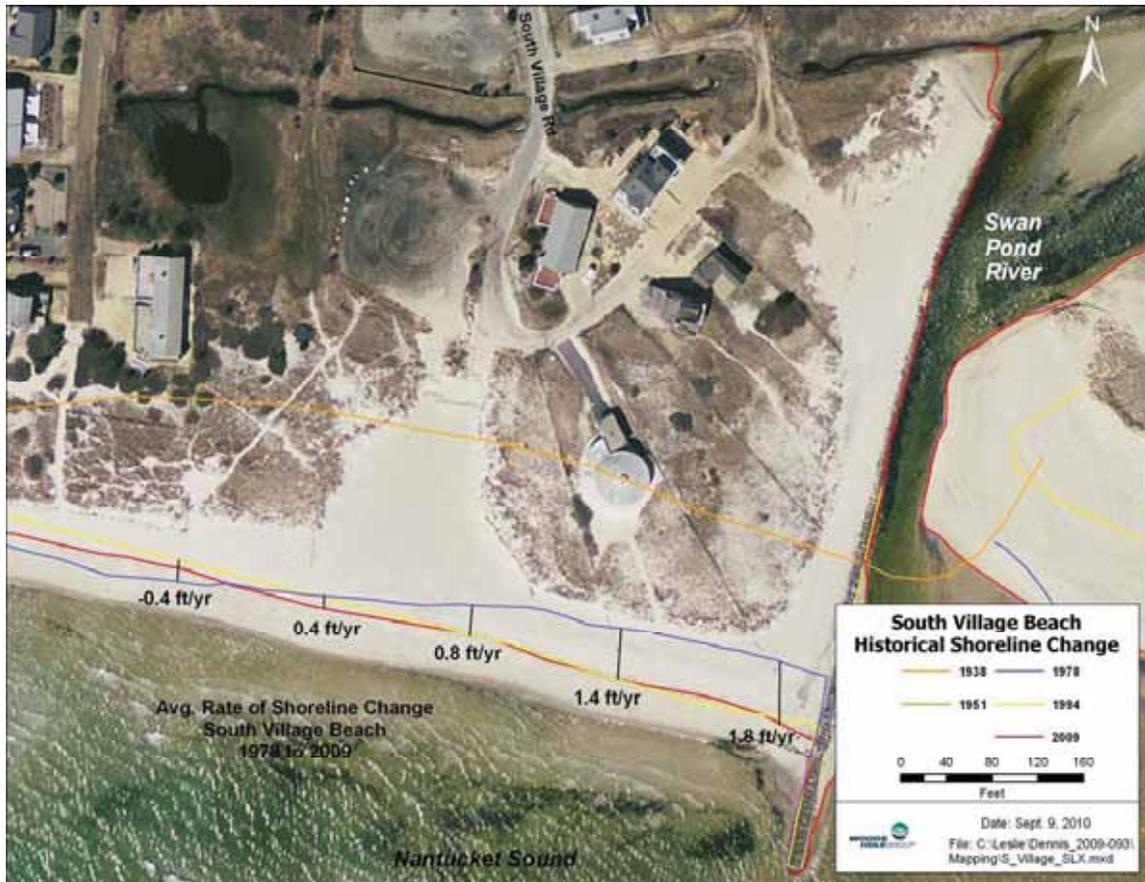
Figure 4-18. Historical shoreline change from 1938 to 2009 for the South Village Beach area.

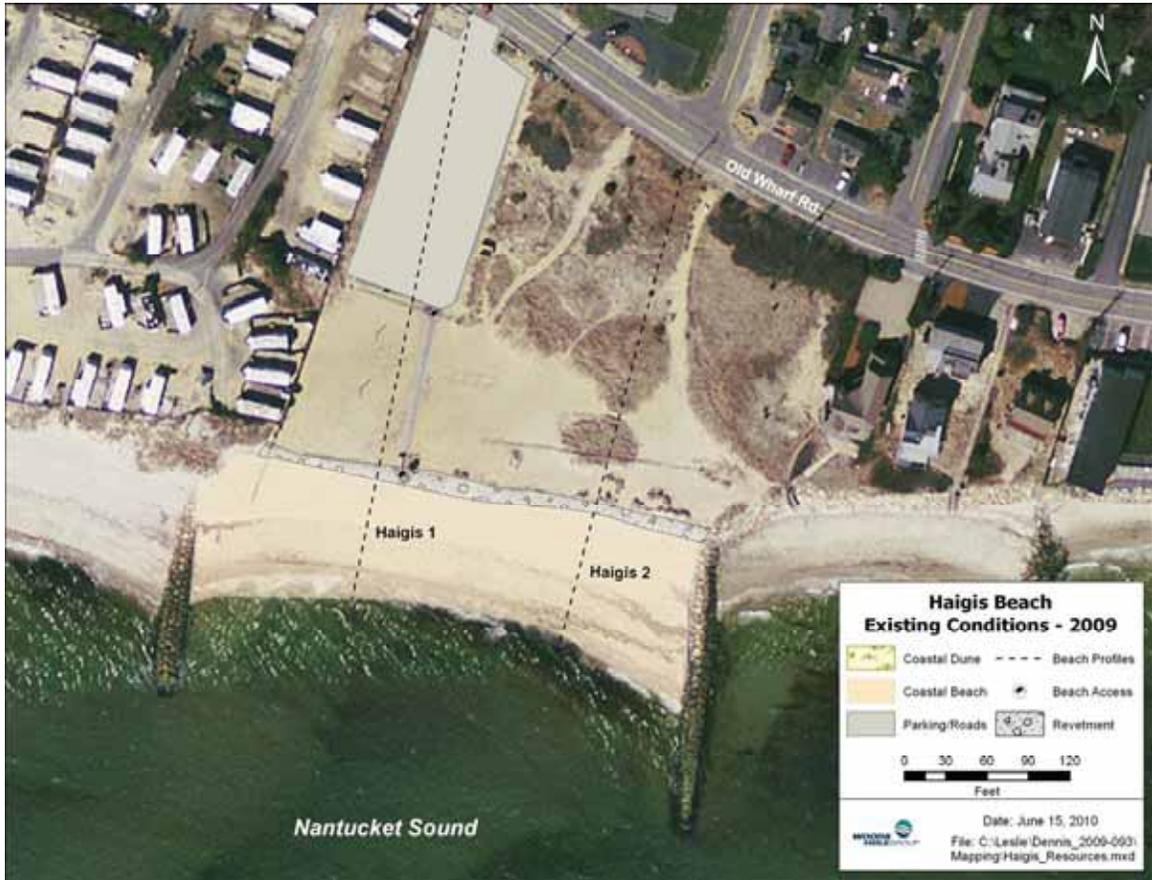
Figure 4-19. Existing conditions map of Haigis Beach.

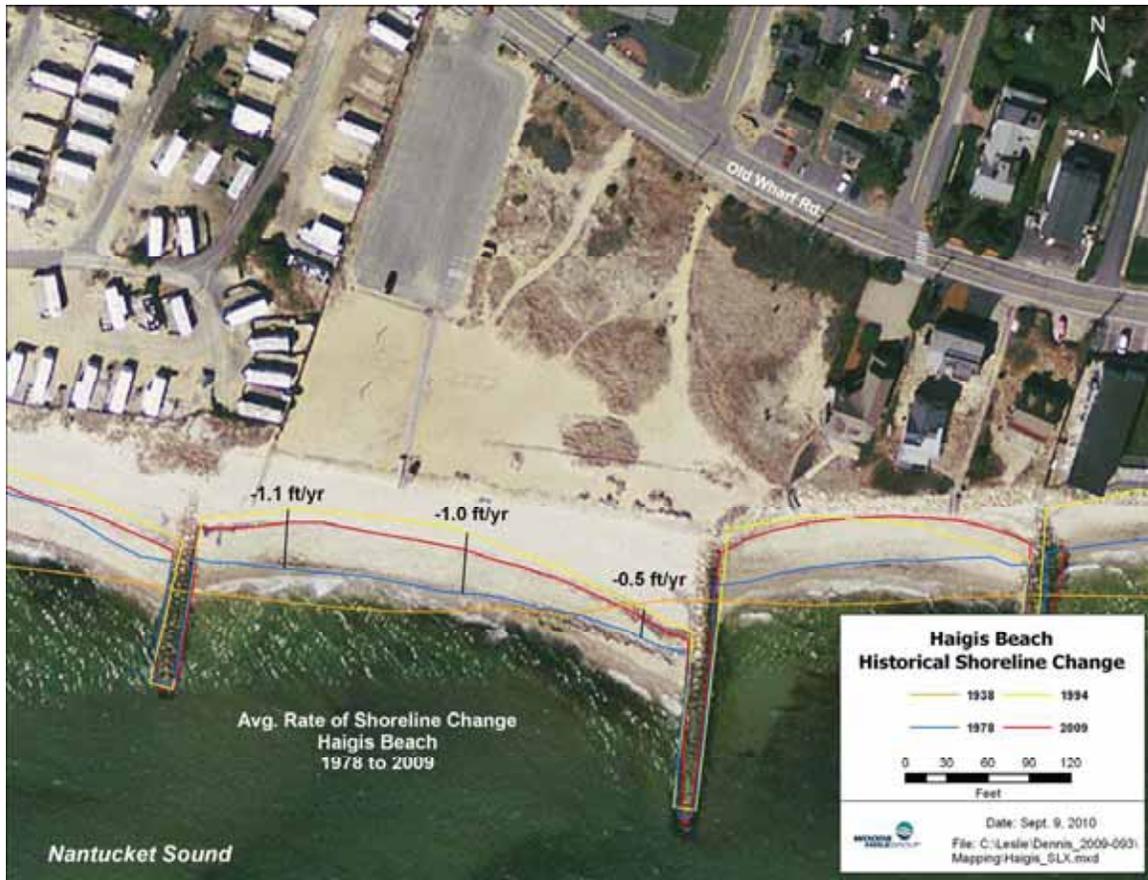
Figure 4-22. Historical shoreline change from 1938 to 2009 for Haigis Beach.

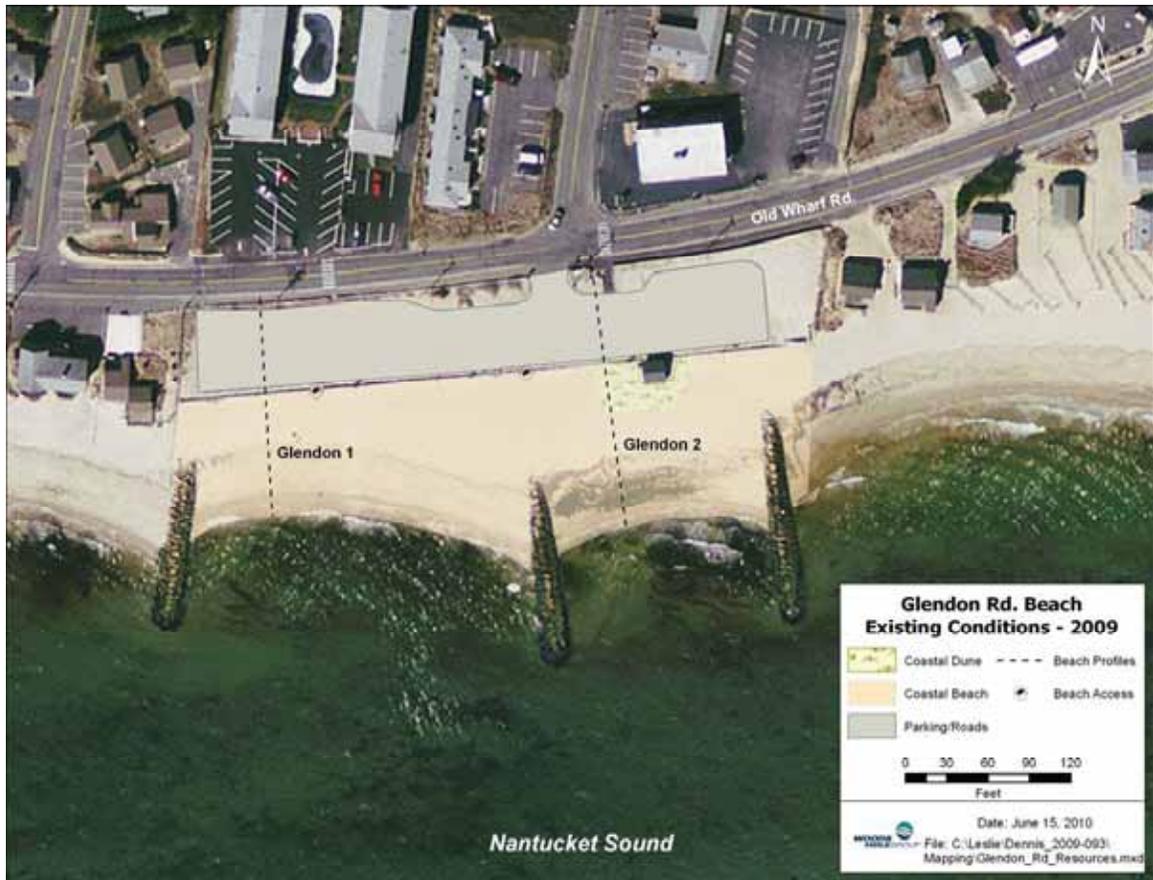
Figure 4-23. Existing conditions map of Glendon Rd. Beach.

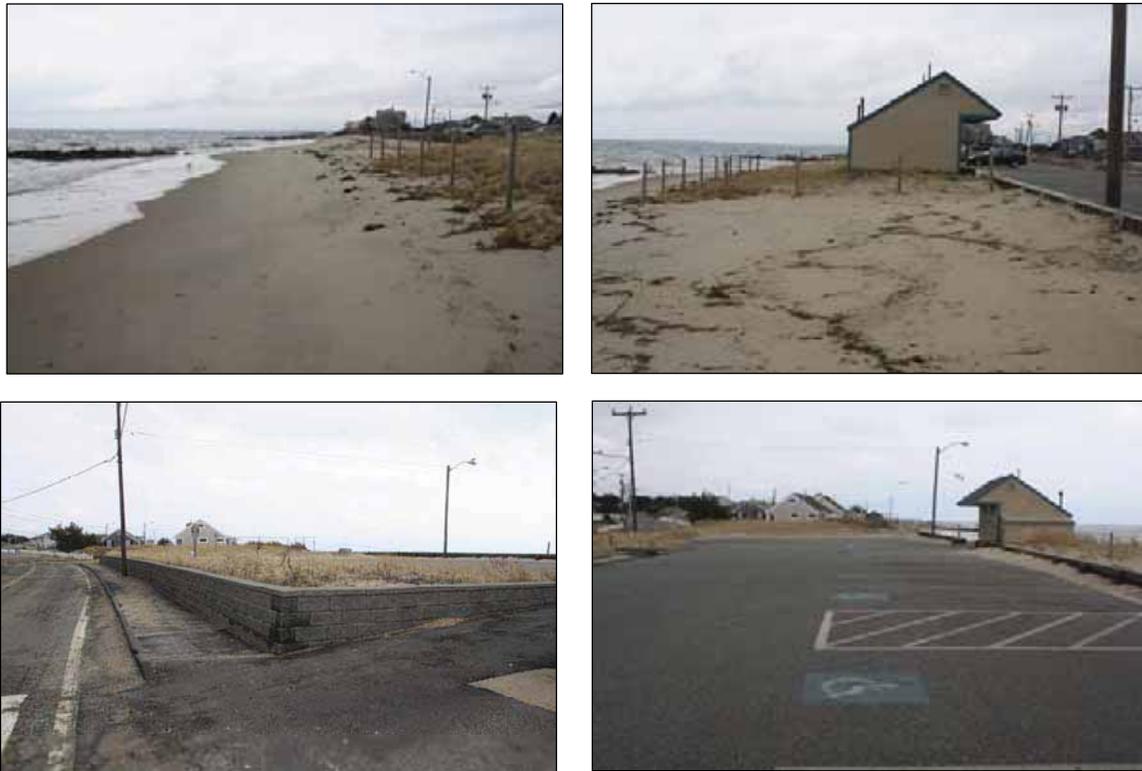
Figure 4-24. Photographs of Glendon Rd. Beach showing the beach and dune resources, as well as the restroom facility, and parking area.

Man-made features at Glendon Rd. Beach include the asphalt parking area, restroom facility, and a retaining wall between the parking lot and sidewalk to contain a septic system for the restrooms. Coastal engineering structures include 3 stone groins and a low-lying timber bulkhead separating the beach from the parking lot. The groins are in good condition, and do not show signs of collapse. The groins do not extend landward far enough to reach the timber bulkhead, and as such allow sediment to move along the beach during storms. The bulkhead top ranges from 0.5 to 3 feet above the elevation of the beach.

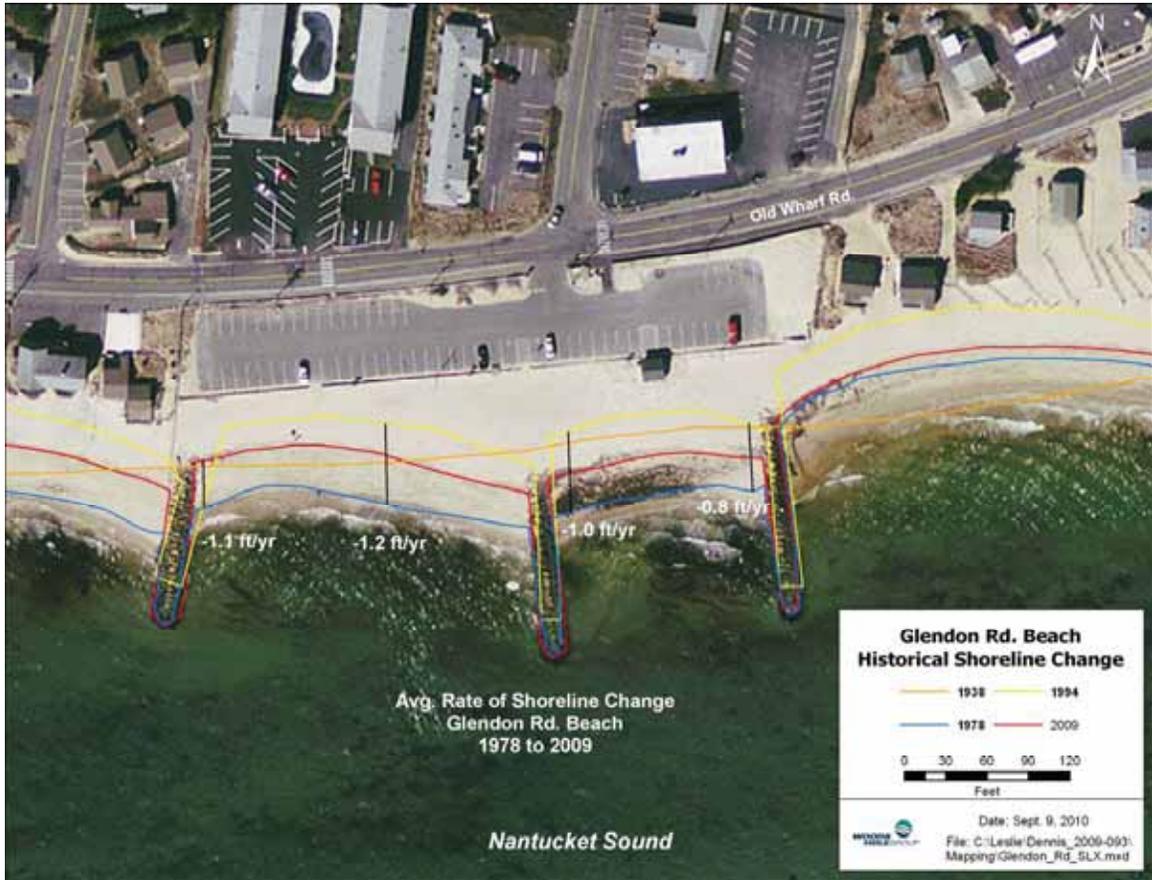
Historical shoreline change positions between 1978 and 2009 for the Glendon Rd. Beach area are presented in Figure 4-26. The data show accretion following the 1938 time period, likely due to the phase of groin building along the south Dennis shoreline. Since 1978 however, the beach has been eroding gradually at an average rate of 1.0 ft/yr.

Figure 4-26. Historical shoreline change from 1978 to 2009 for the Glendon Rd. Beach area.

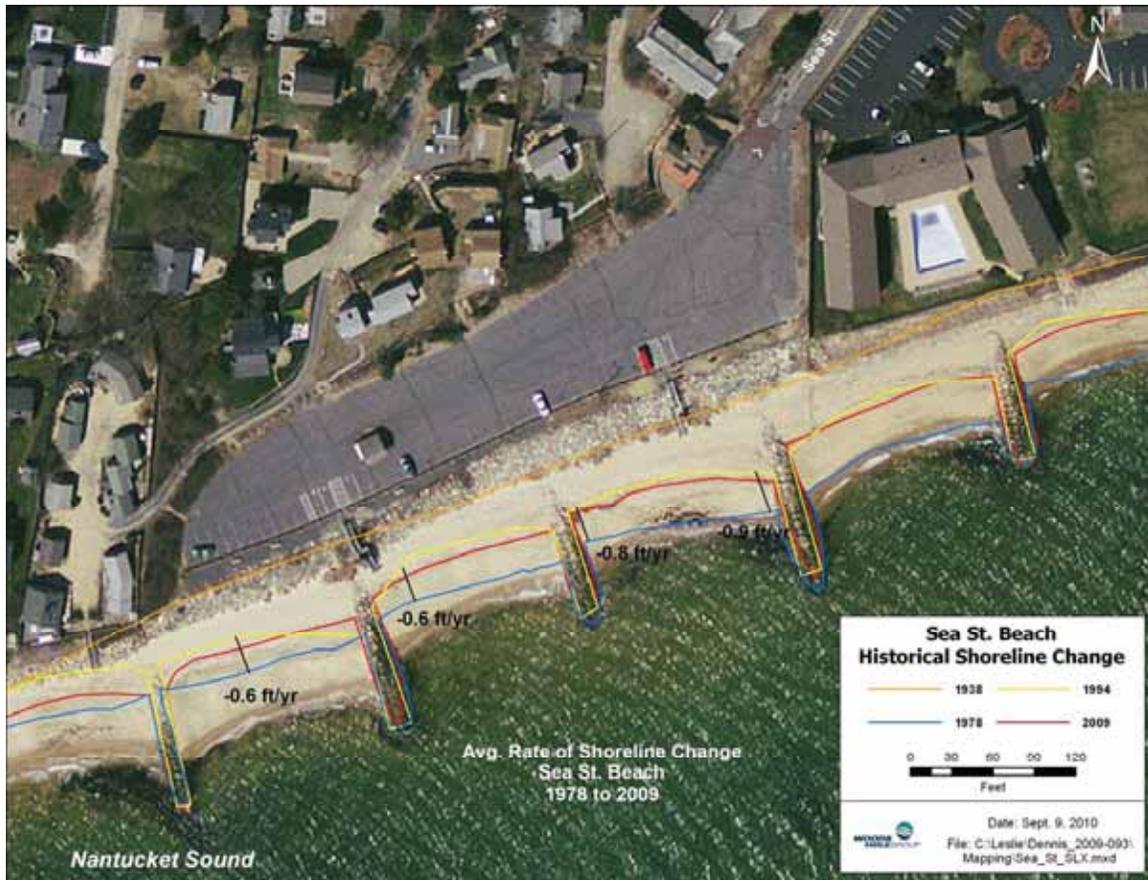
Figure 4-30. Historical shoreline change from 1938 to 2009 for the Sea St. Beach area.

Historical shoreline change positions between 1938 and 2009 for the Sea St. Beach area are presented in Figure 4-30. The data show accretion following the 1938 time period when many of the groins were built along the south Dennis shoreline. Between 1978 and 1994 the shoreline experienced a net erosion, and over the past 15 years the shoreline has remained relatively stable, showing little net accretion or erosion. Long-term rates of change computed over the period 1938 to 2009 show an average rate of change on the order of +0.5 ft/yr; however, when considering the most recent 15 year time period the average rate of change is near zero.

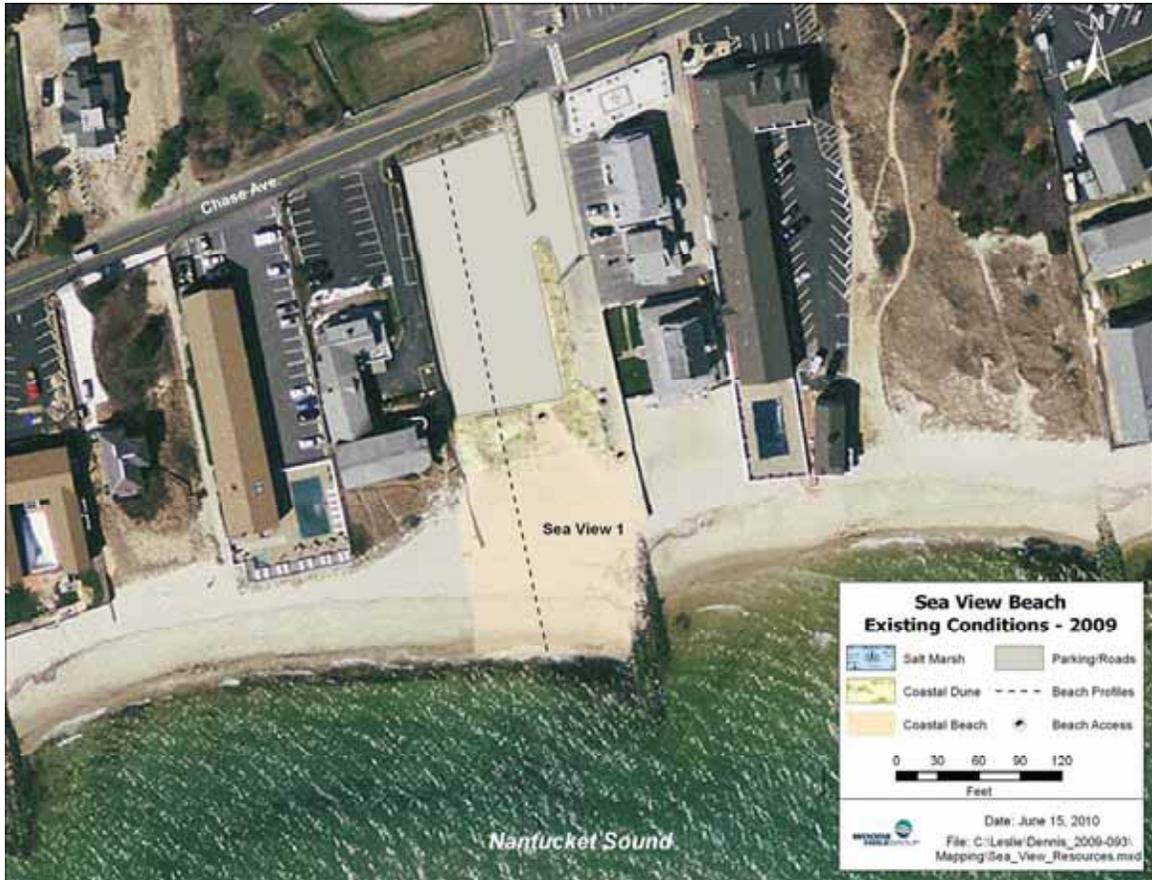
Figure 4-31. Existing conditions map of Sea View Beach.

The public beach parcel at Sea View Beach is approximately 0.7 acres in size (Figure 4-31). The site contains a parking area, as well as Coastal Dune and Coastal Beach resources (Figure 4-32). The dunes are well vegetated with beach grass and provide a short path for access to the beach. Development on either side of the public beach parcel has minimized the room for dunes to develop, and as such the resource at the Sea St. Beach site is nearly an isolated feature. Beach sediments are composed of well-sorted medium to fine-grained sands with a median diameter of 0.34 mm (Appendix A). According to the Massachusetts Natural Heritage and Endangered Species Program (NHESP; 13th Atlas Edition, 2008), Sea View Beach is not mapped as Estimated or Priority habitat for rare or state-listed rare wildlife.

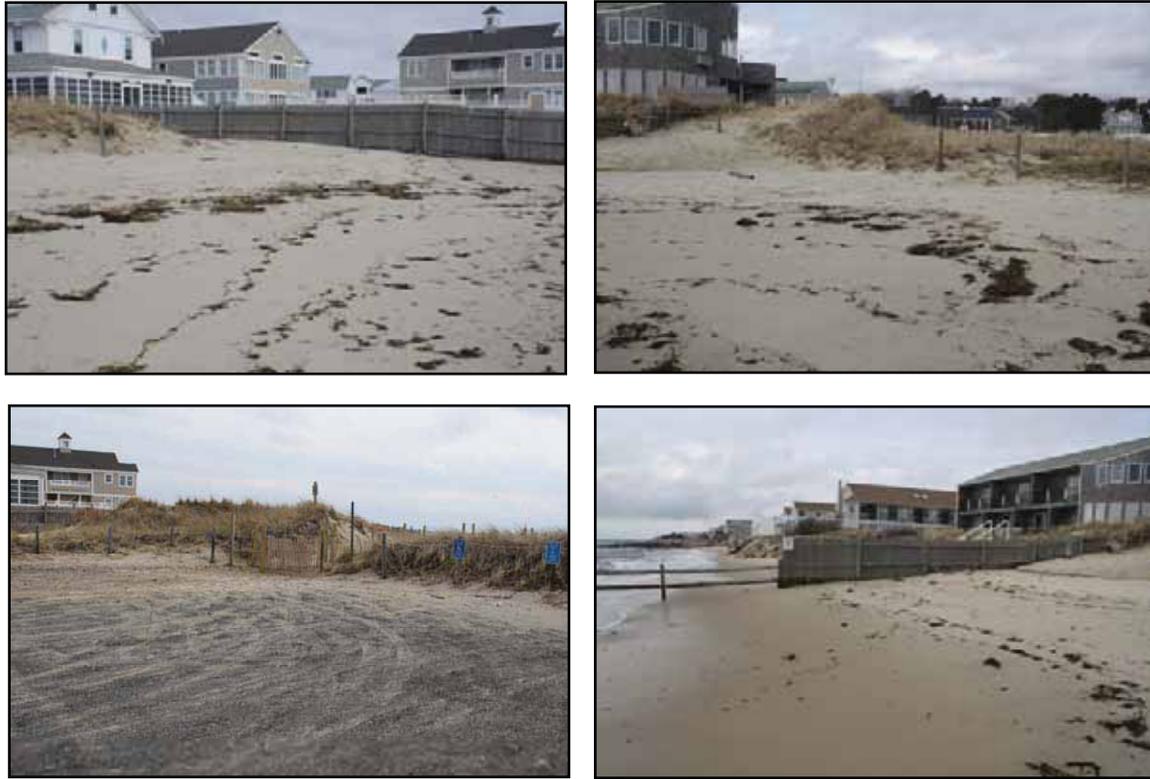
Figure 4-32. Photographs of Sea View Beach showing the beach and dune resources as well as the natural surface parking area.

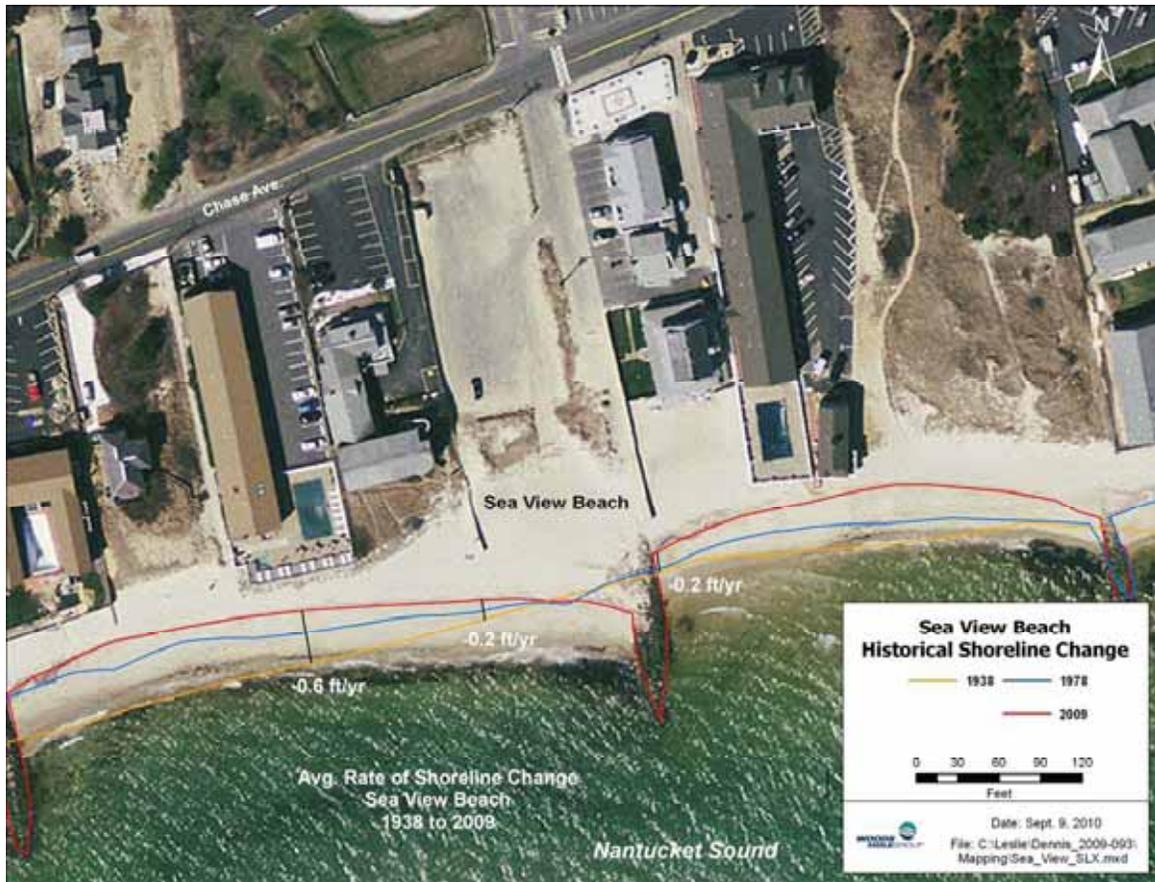
Figure 4-34. Historical shoreline change from 1938 to 2009 for the Sea View Beach area.

Historical shoreline change data for Sea View Beach are shown in Figure 4-34. The data indicate that the beach has remained relatively stable over the 71 yr period since 1938. Average long-term rates of change between -0.2 ft/yr and -0.6 ft/yr suggest that the beach is slightly erosional to stable.
