# Long-Term Resiliency-Building Alternatives for Haigis Beach

Public Meeting #1

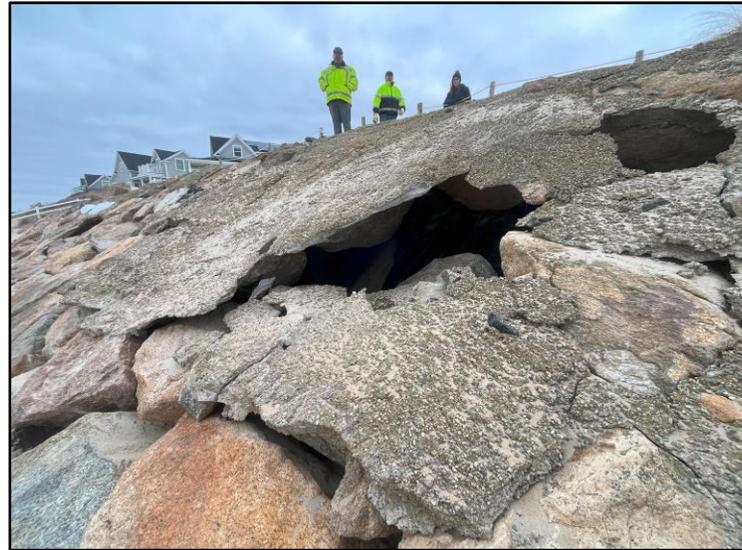
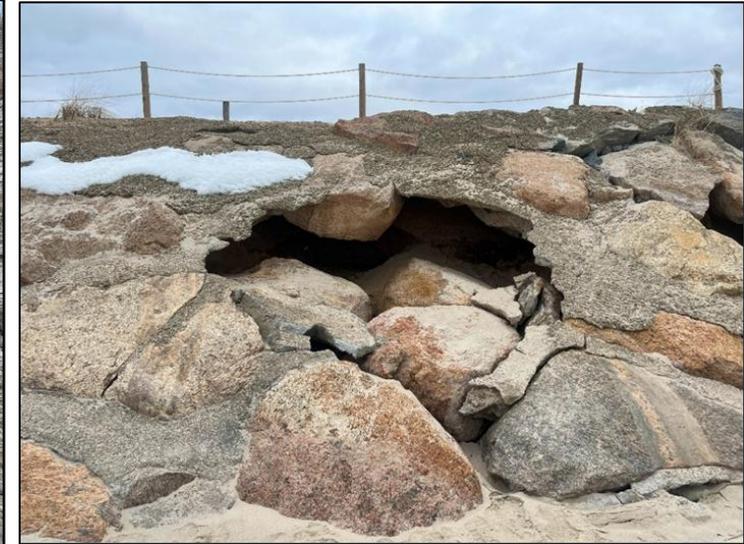
Damage to Haigis Beach rock revetment following sou'easter storm events.

- Wave impacts have damaged the rock revetment, forming voids and creating a public safety hazard.
- Waves overtopping the rock revetment have led to undermining and slumping of sand located along the crest.
- Without substantial maintenance, the sloping rock revetment is reaching the end of its serviceable lifespan.
- ***Risk of repetitive loss.***

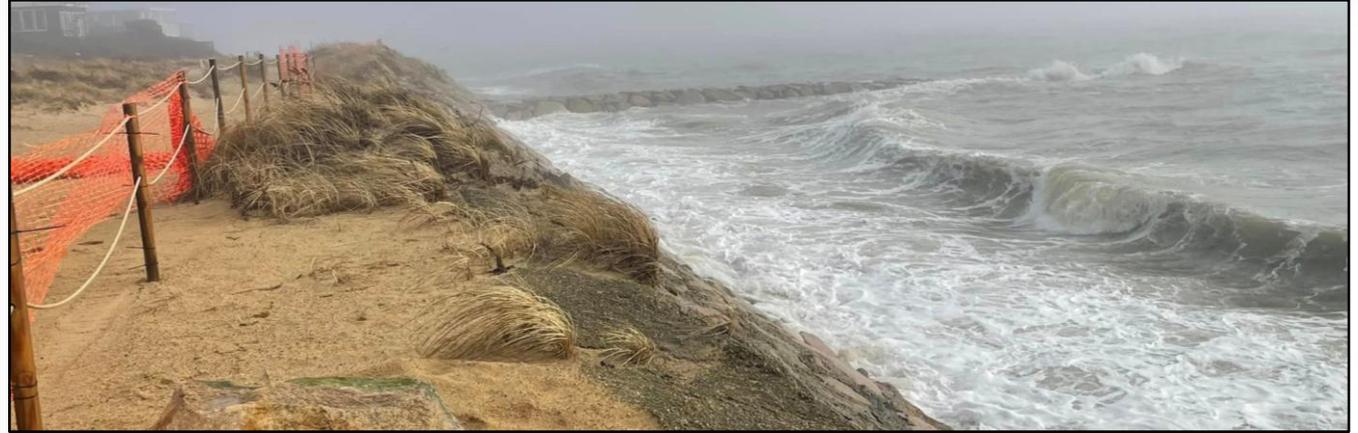
2024 Winter Storm Impacts

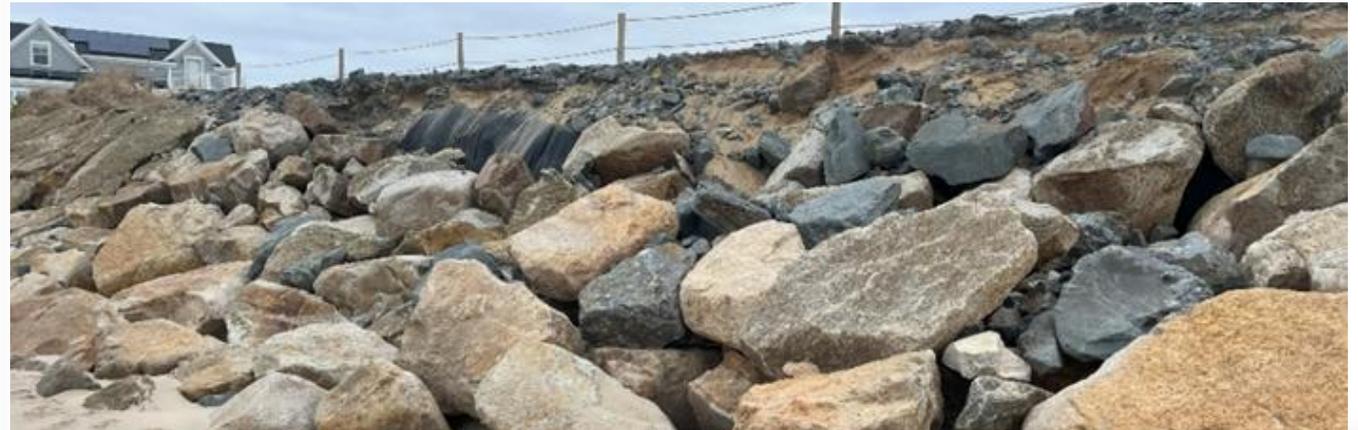
Emergency Repairs

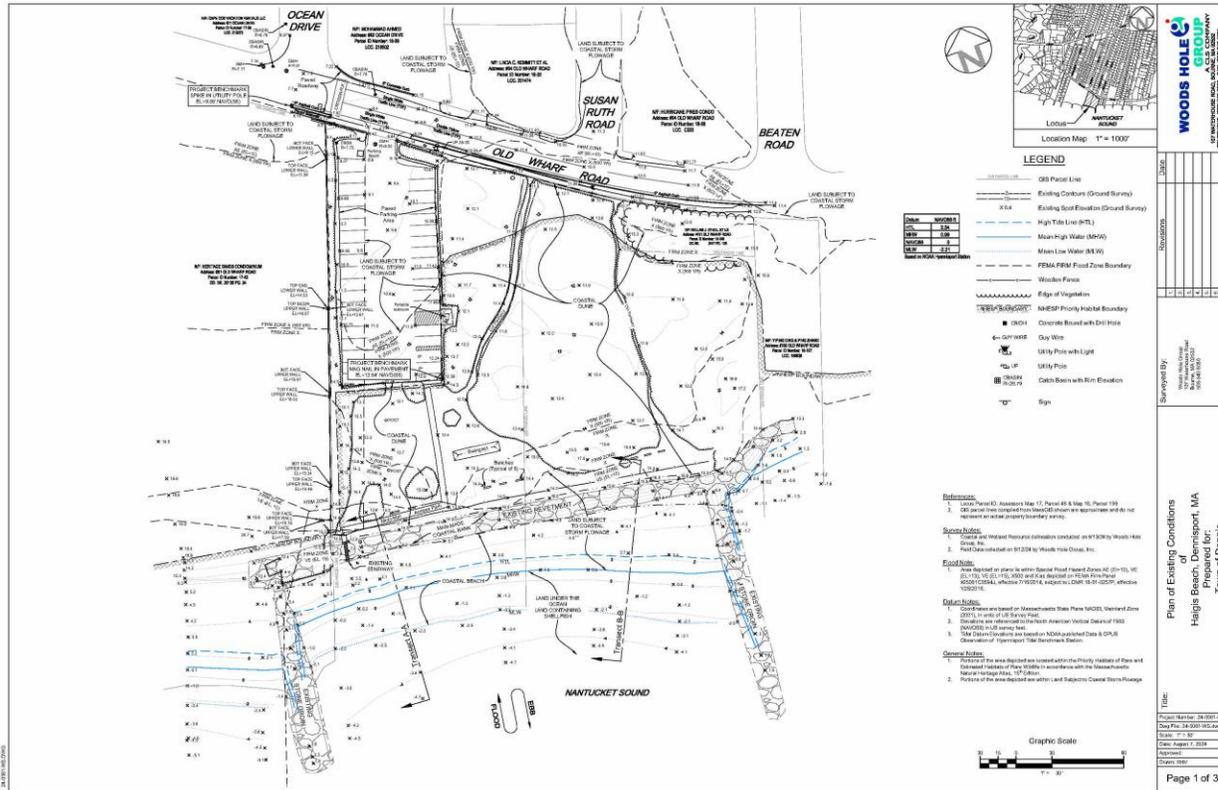
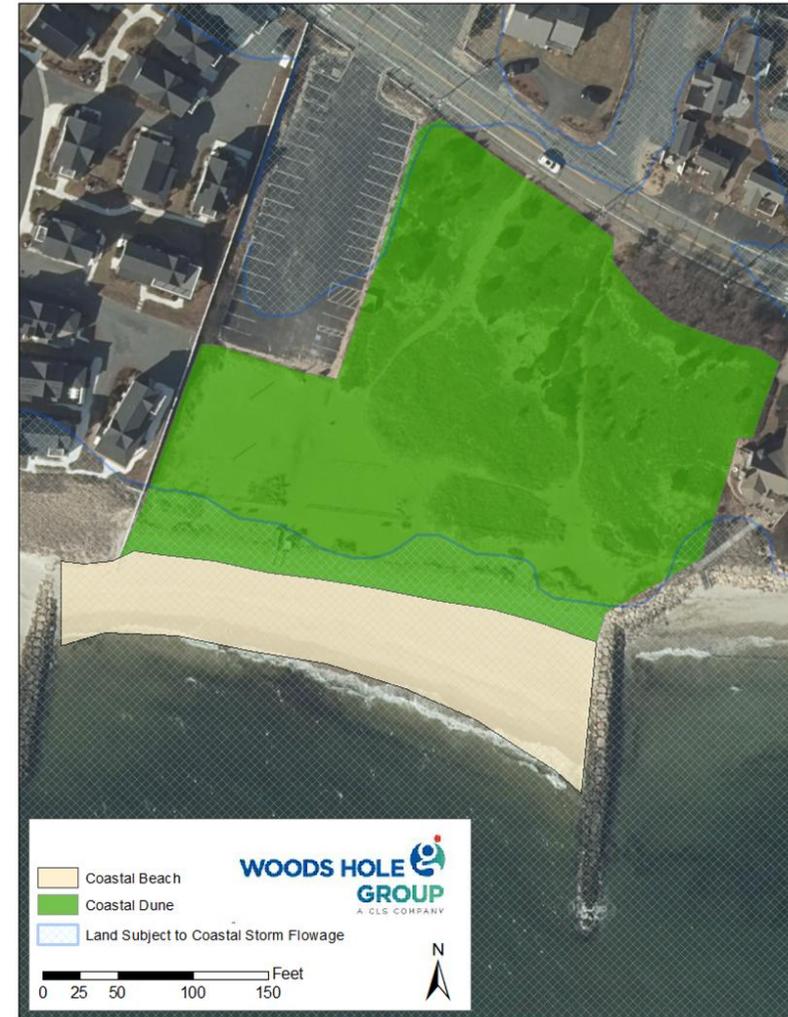
- Necessary 1<sup>st</sup> step in the process
- Coastal dune and coastal beach resource areas
- Surveyed topography, parcels, and Town assets

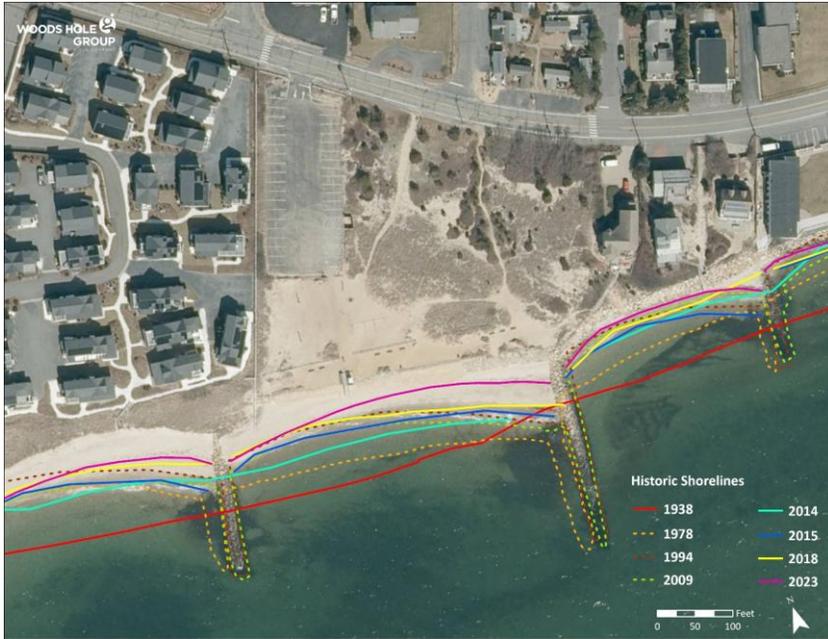
Historical shoreline positions along Haigis Beach.

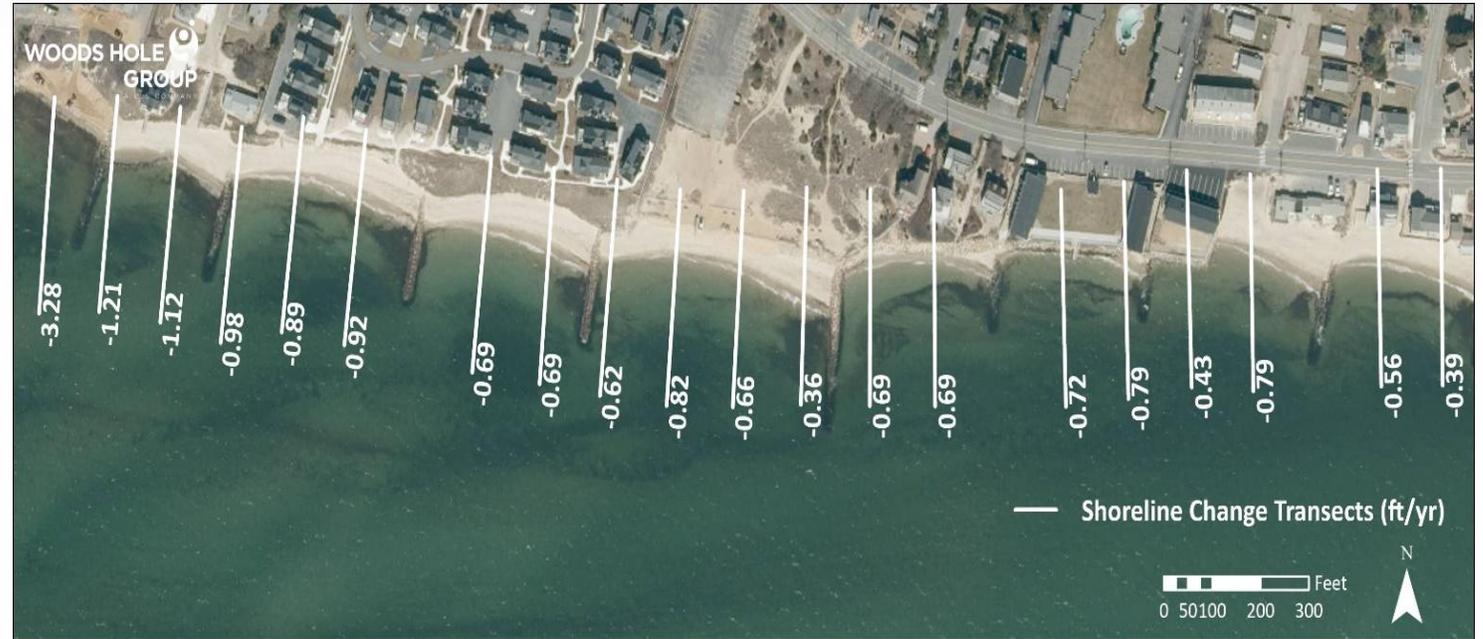
Long-term transects (1938-2023).

- Haigis Beach shoreline is largely erosional (-0.62 ft. / yr.)
- Coastal engineering structures dampen rate of change
- Structures disrupt natural coastal processes – erosion, sed. tx., etc.
  - Less sand erodes in the winter to rebuild beach in the summer
  - Over time, less high tide beach available for recreation

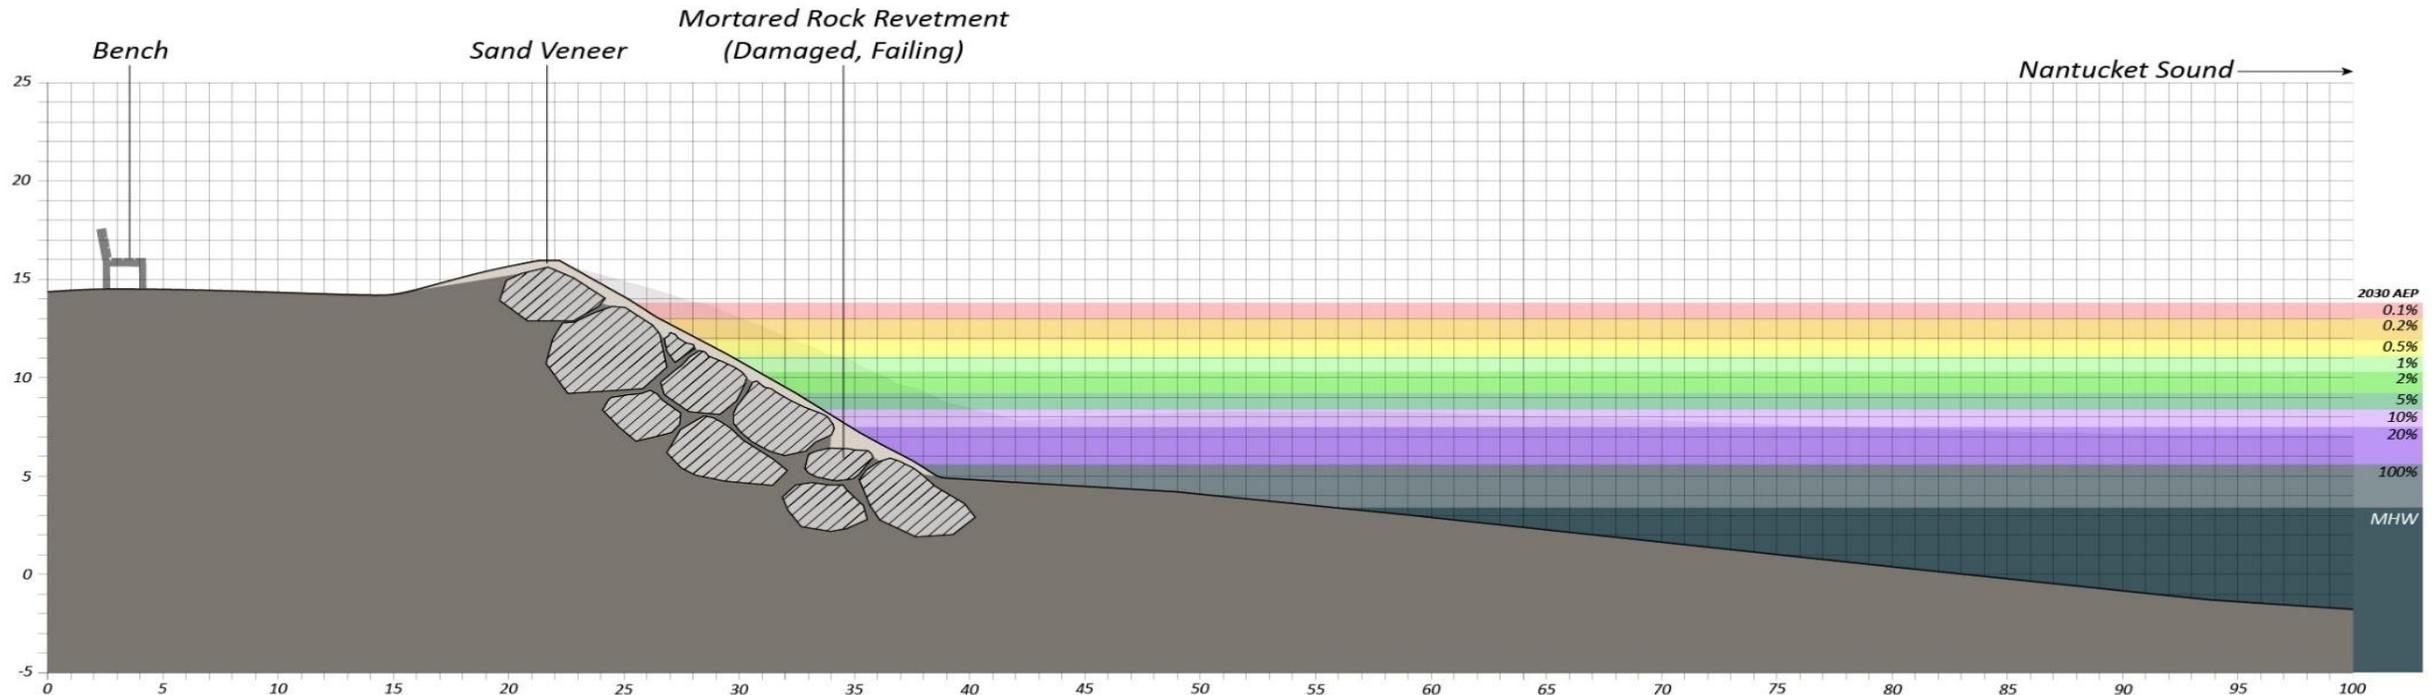
Haigis Beach, Dennis

- Massachusetts Coast Flood Risk Model – State standard for infrastructure planning
- Illustrate how high tide and coastal storm surge elevations are expected to change over time
- Excellent point of reference for coastal planning and design

**EXISTING CONDITIONS - 2030 MC-FRM WATER SURFACE ELEVATIONS**

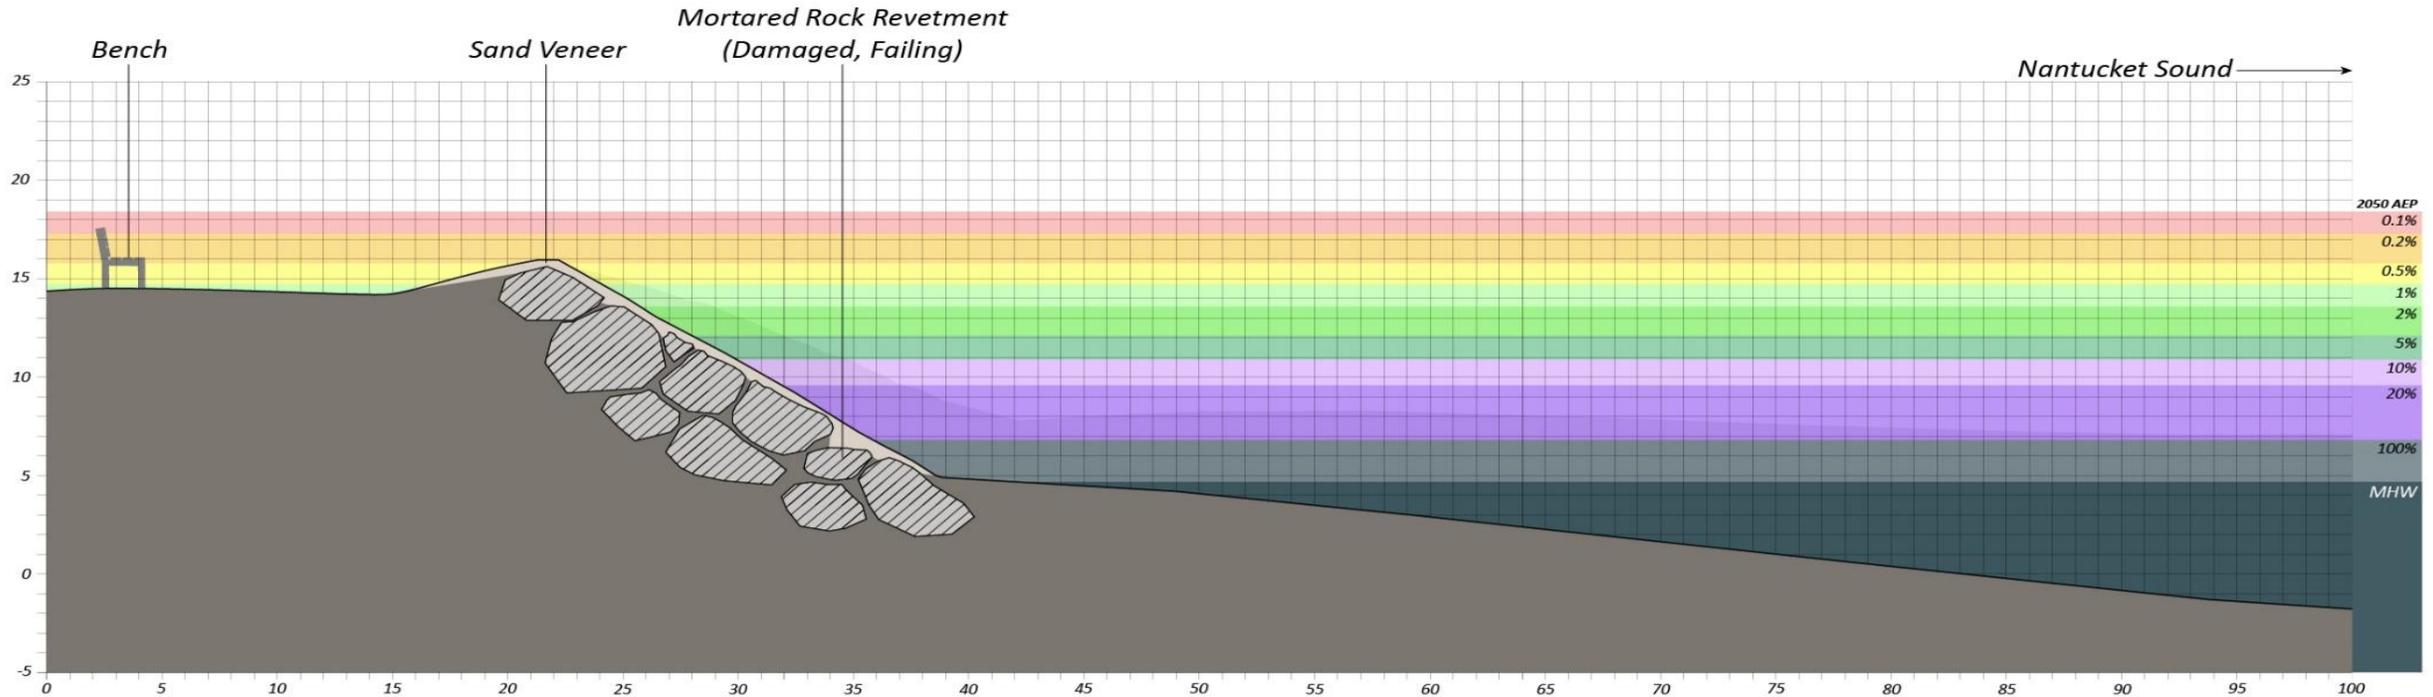
Haigis Beach, Dennis

- Rising tides and storm water levels through 2030, 2050, 2070 planning horizons.

**EXISTING CONDITIONS - 2050 MC-FRM WATER SURFACE ELEVATIONS**

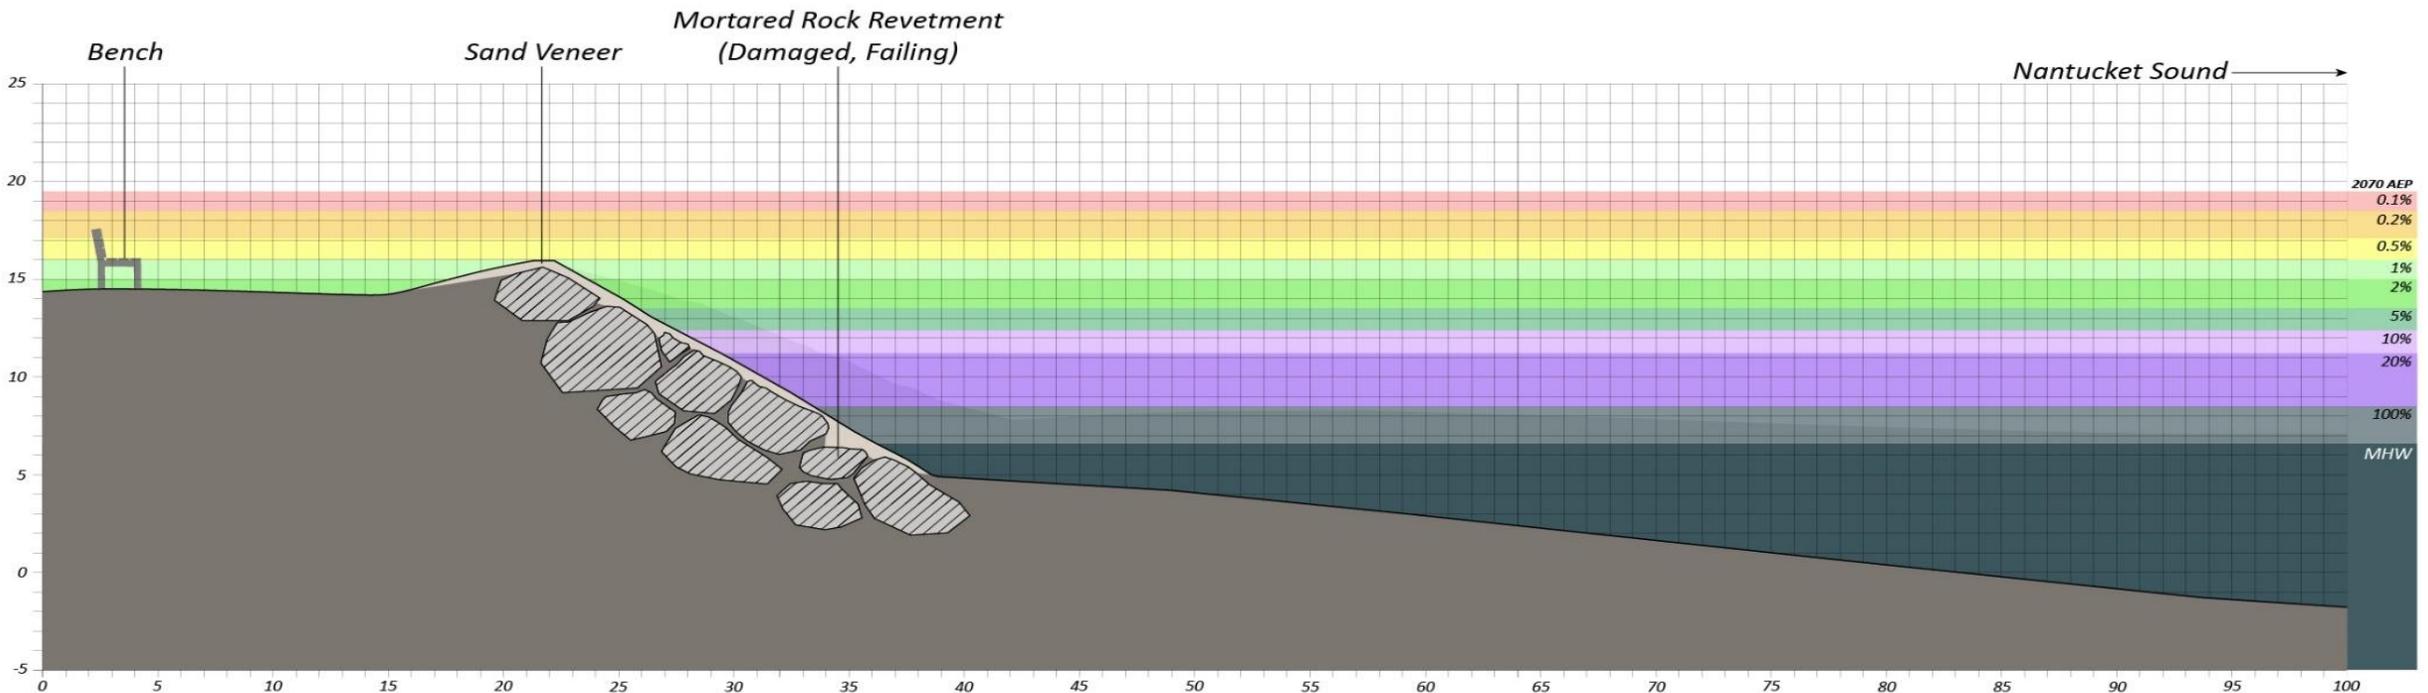
Haigis Beach, Dennis

- Over the 2030-2070 planning horizon, water surface elevations associated with high-intensity storm events will begin to overtop the existing rock revetment.
- Over the 2030-2070 planning horizon, water surface elevations associated with high tide and low-intensity storms (annual nor'easter, or similar) will inundate the bottom half of the existing rock revetment.

**EXISTING CONDITIONS - 2070 MC-FRM WATER SURFACE ELEVATIONS**

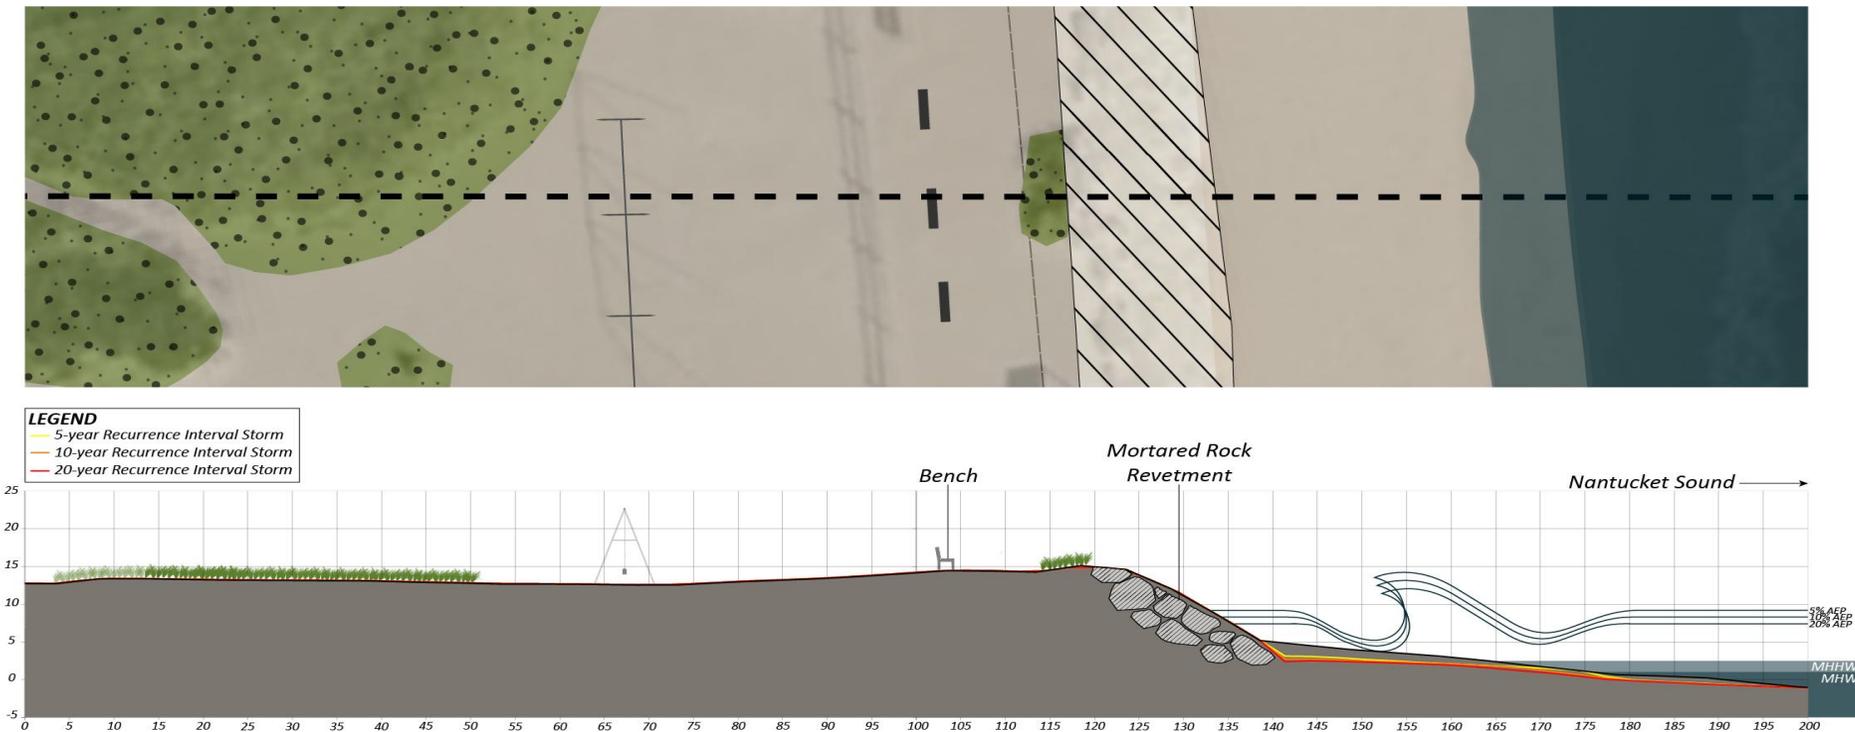
Haigis Beach, Dennis

- Cross-shore modeling illustrates how the shoreline erodes during a storm and how sand is redistributed.
- With the revetment in place, results show very little erosion landward of the revetment through 2070.
- Scour along the toe of the revetment is expected.

### EXISTING REVETMENT - 2030 PERFORMANCE

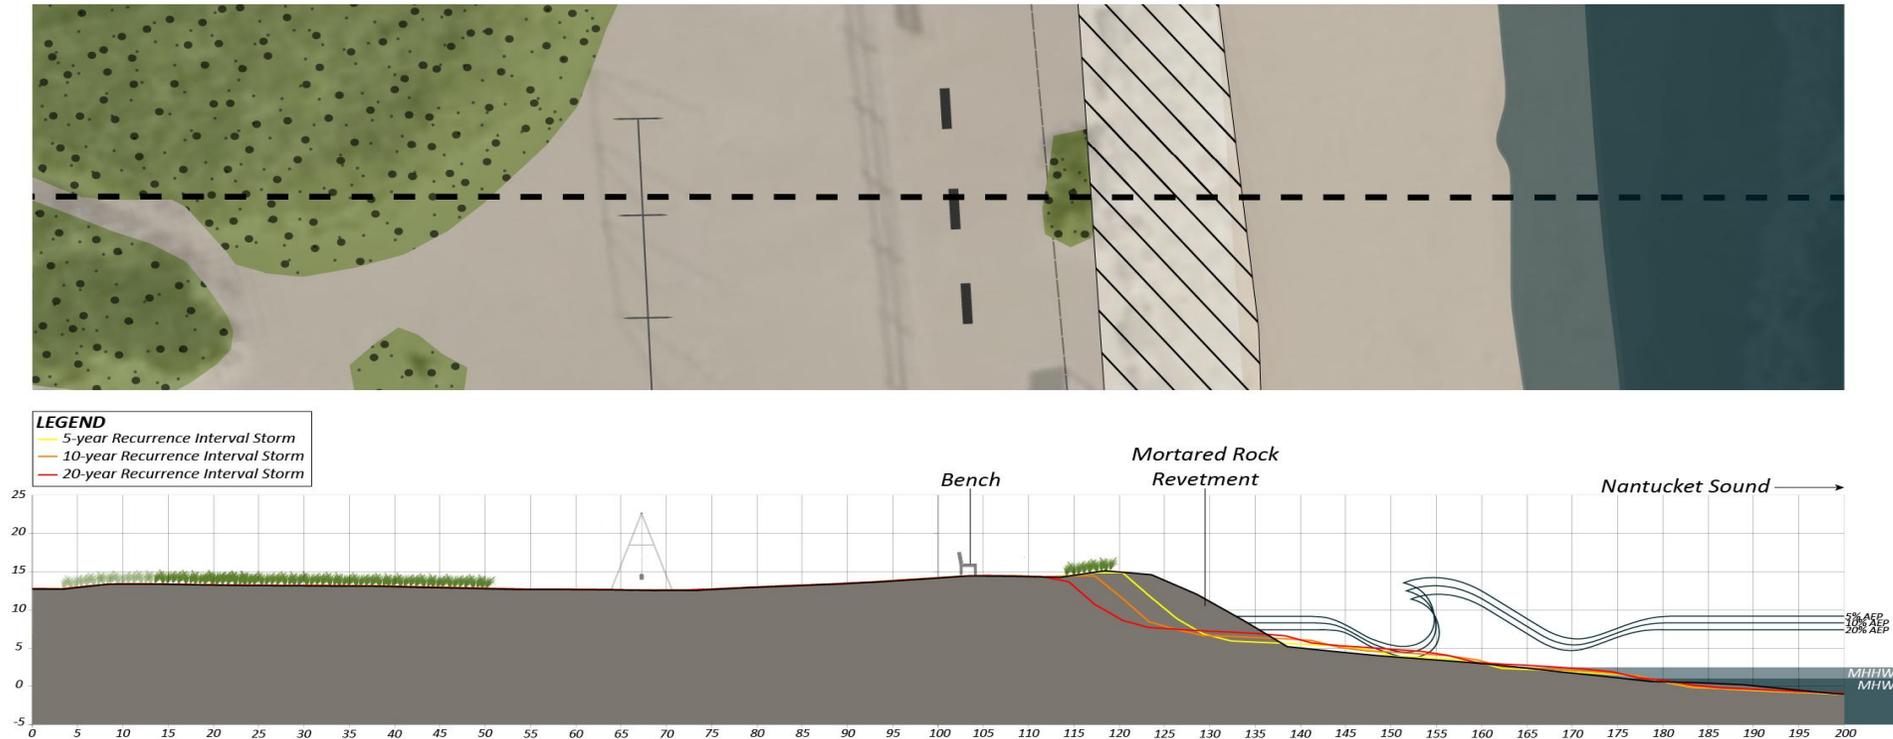
Haigis Beach, Dennis

- With the revetment removed from the analysis and natural dune landform exposed, results show increasing severity of erosion during 5-, 10-, and 20-year storm events through 2070.

### REVTMENT REMOVED - 2030 PERFORMANCE

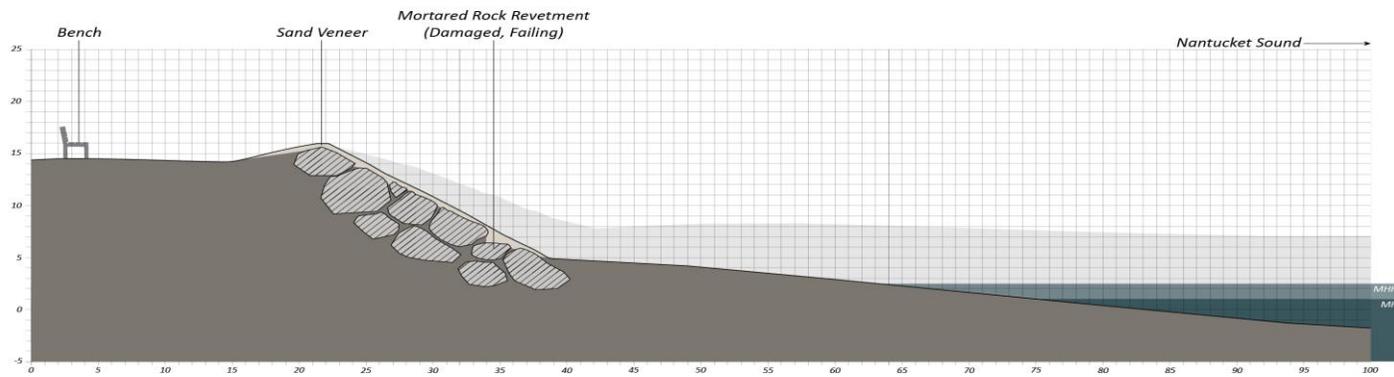
EXISTING CONDITIONS  
Haigis Beach, Dennis
