# Dr. Bottero Road Chapin Beach Access Ramp Alternatives Analysis Town of Dennis, MA

June 30, 2011

**Town of Dennis  
Department of Natural Resources,  
Shellfish, and Conservation**

**THE Louis Berger Group, INC.**

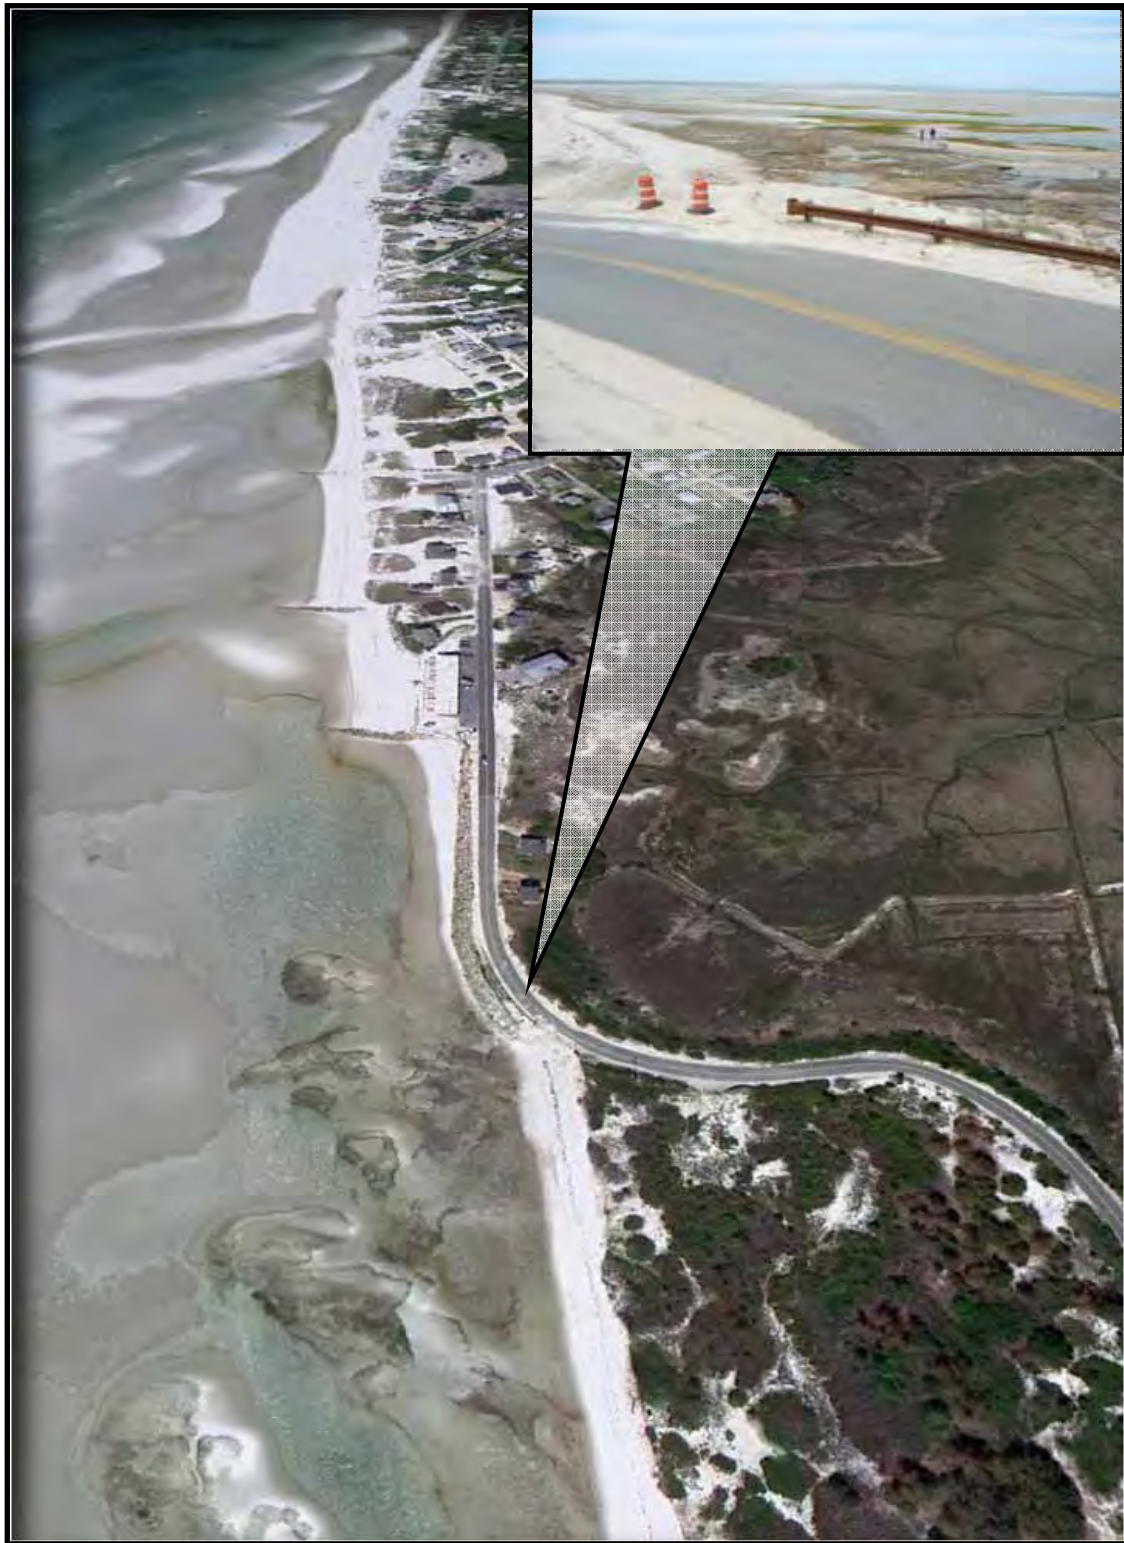
**Figure 1: Dr. Bottero Road Aerial View**

The on-going “end effect” scour at the western end of the armor stone revetment protecting Dr. Bottero Road is a long-term concern and currently requires substantial routine maintenance in the form of regular small-scale sand nourishment to protect the roadbed from undermining. The current undermining of the revetment terminus indicates structural instability and it does not appear that the small-scale sand nourishment placed in this area provides enhanced protection during significant storms. To assure long-term shore protection of the roadway, a reassessment of the existing coastal armoring, as well as an evaluation of alternatives that would provide long-term shore protection for this region was jointly conducted by the Louis Berger Group, Inc. located in Needham and Applied Coastal Research and Engineering, Inc. located in Mashpee. This report expands upon limited shoreline change rate information provided in the Final Waterways Assets and Resource Survey Master Plan for Dredging and Beach Nourishment (2010) as the basis for shore protection design recommendations. Alternatives to enhance protection will include:

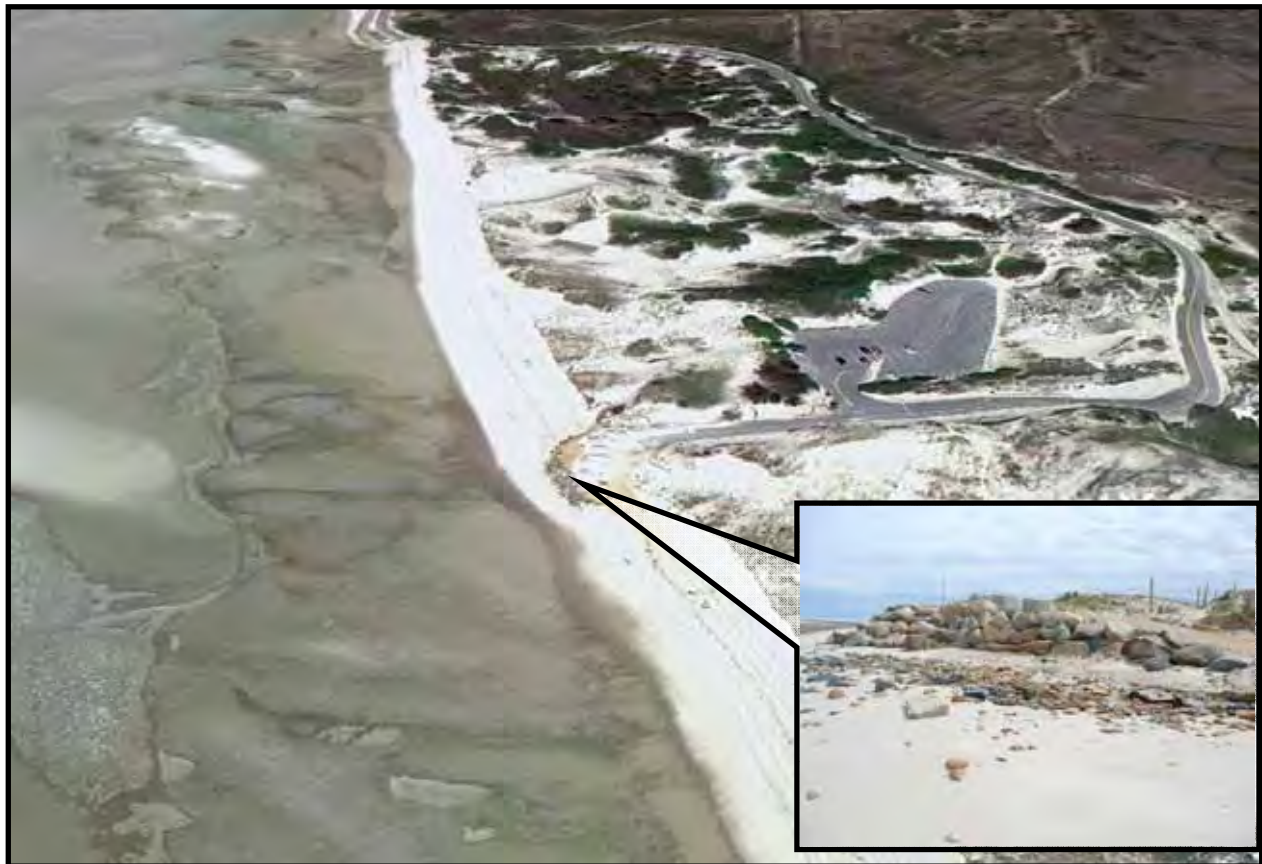
**Figure 2: Chapin Beach Aerial View**

Observations of the Off-Road Vehicle (ORV) access ramp to Chapin Beach suggest it likely cannot be maintained in its present position, since the seaward extent of the dune has migrated landward of the existing paved ramp. As a result, the ramp necessary to provide access to the beach requires reconstruction each spring to allow vehicular access to the shoreline west of the existing beach parking lot. To address this issue, a schematic design for a managed retreat for the access ramp was developed along with a description of the basis of the design, feasibility of construction, and a conceptual cost opinion for further design, permitting, construction, and maintenance.

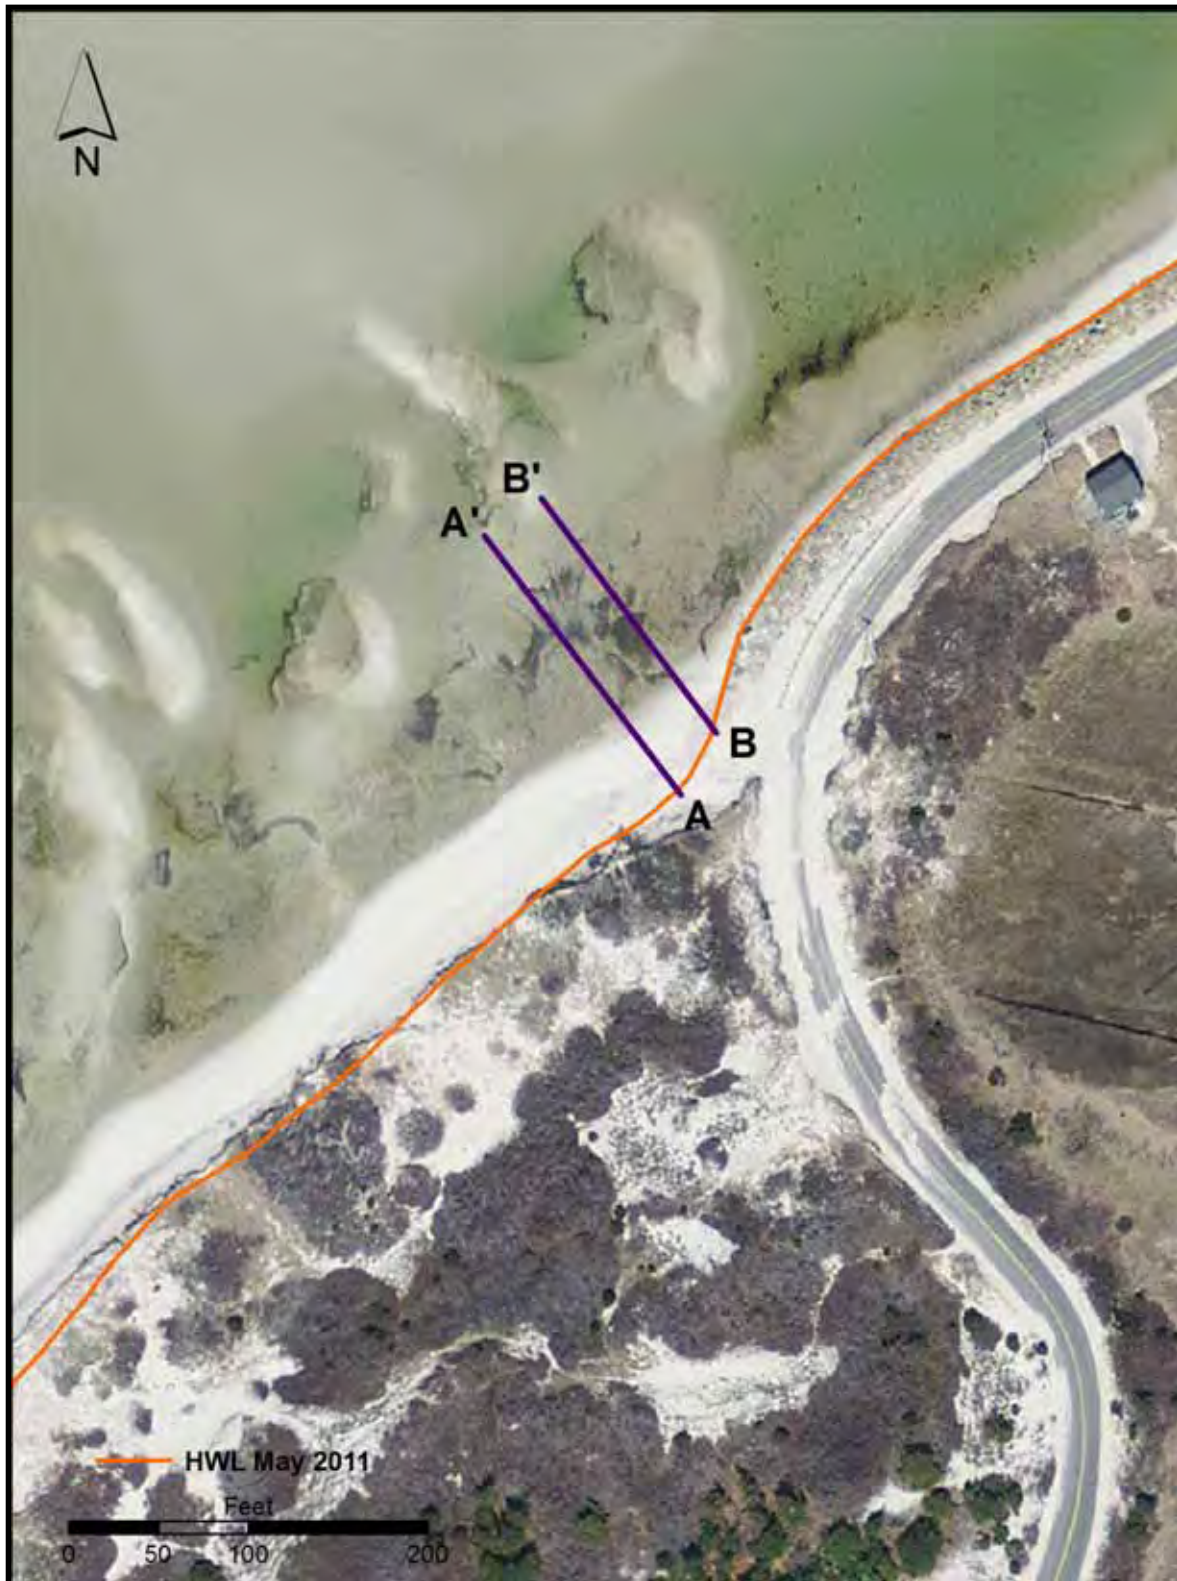
Figure 7: Location of Beach Transects Measured at the West End of the Dr. Bottero Road Revetment

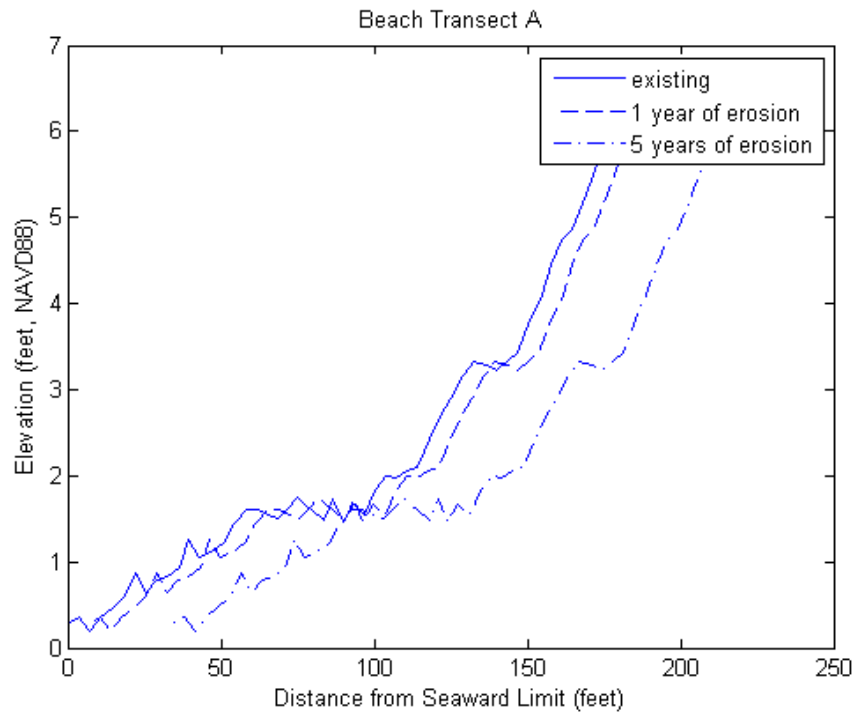
**Figure 8: Beach Transect A for Existing Conditions, as well as Anticipated Positions after 1 Year and 5 Years of Ongoing Erosion**

For the no-action alternative, coastal erosion can be expected to continue at its present rate. This will likely have significant consequences to the roadway leading to the beach parking lot, ORV access to the beach, and the Aquiculture Research Corporation. As the long-term littoral sediment deficit continues, the shoreline will continue to migrate landward at critical locations requiring additional shore protection. Specifically, the western terminus of the revetment fronting Dr. Bottero Road has been undermined during recent winter storms. At the ongoing erosion rate of approximately 6.5 feet per year (Figure 4), additional emergency fill will not be able to maintain the roadway beyond the next 1-3 years. To illustrate the anticipated erosion effects in this region (shown in Figure 7), the existing beach transects, labeled A and B, are shown in Figures 8 and 9, along with projected future shoreline locations. Within 5 years, the shoreline location for Transect B will be in the roadway. With only the existing practice of placing emergency fill following storms, the roadway cannot be maintained; therefore, the 'no action' alternative was considered unacceptable.

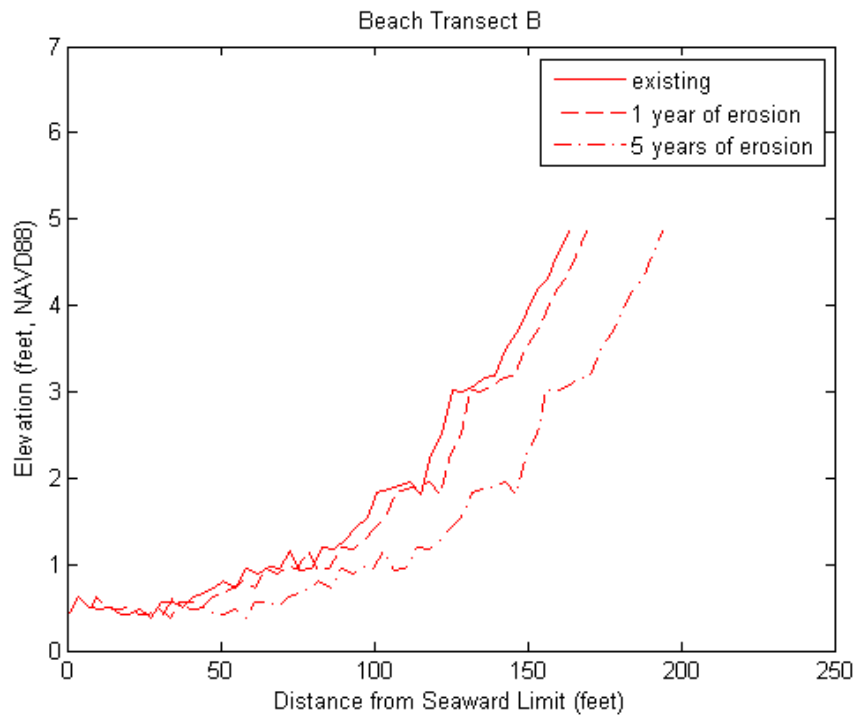
**Figure 9: Beach Transect B for Existing Conditions, as well as Anticipated Positions after 1 Year and 5 Years of Ongoing Erosion**

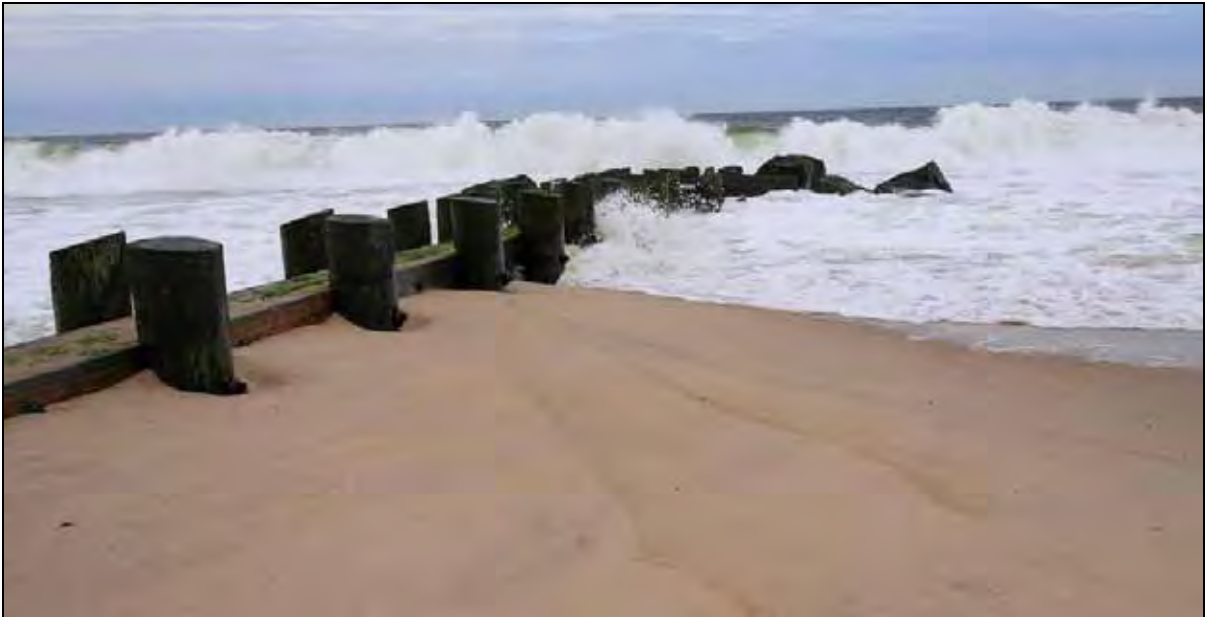
**Figure 13: Example of Timber Groin, where Height cannot be Adjusted**

To extend the design-life of a potential nourishment project, adjustable timber groins could be placed to maintain a high tide beach fronting the western portion of the existing unstable revetment. Once nourishment within the groin 'cells' has been established, on-going nourishment will be required to prevent downdrift impacts. Annual fill likely would be required to keep the groin field filled to entrapment. Based on typical annual erosion rates, this volume is estimated to be approximately 300 cubic yards of beach nourishment.

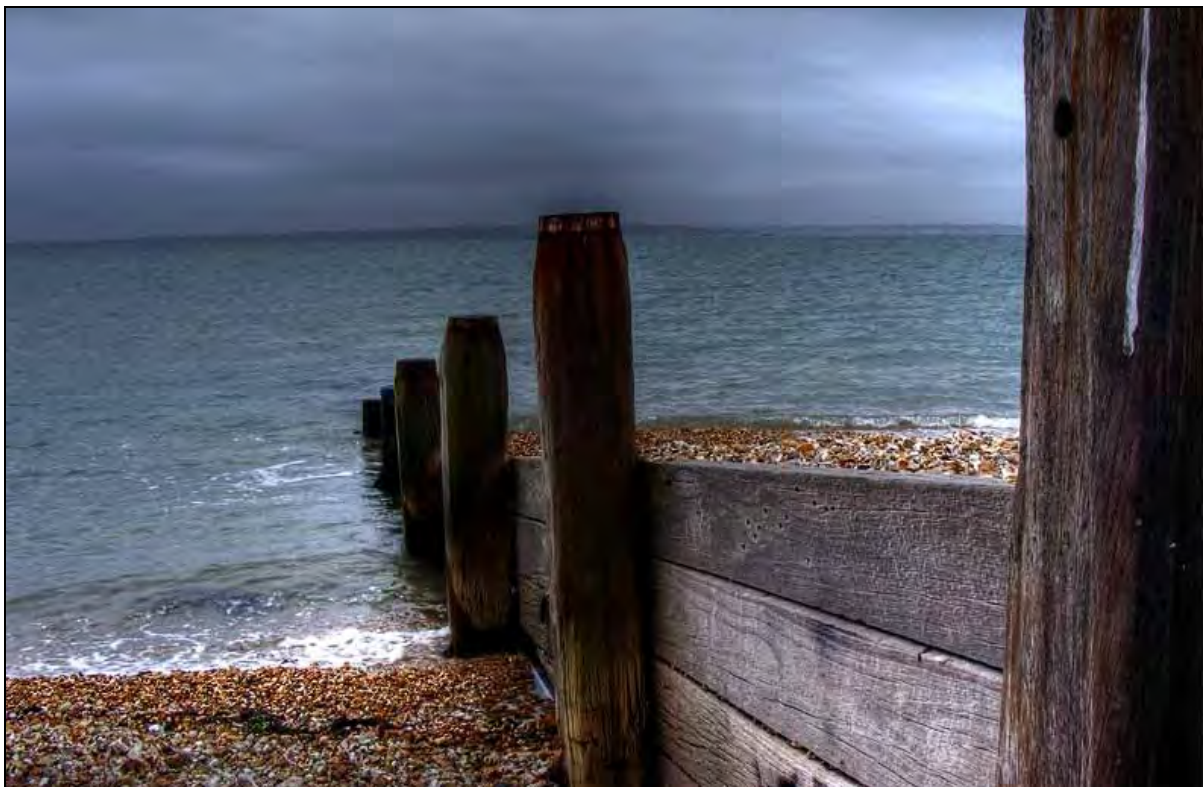
**Figure 14: Example of Timber Groin, where Lagging can be Readily Removed or Added to Adjust Height**

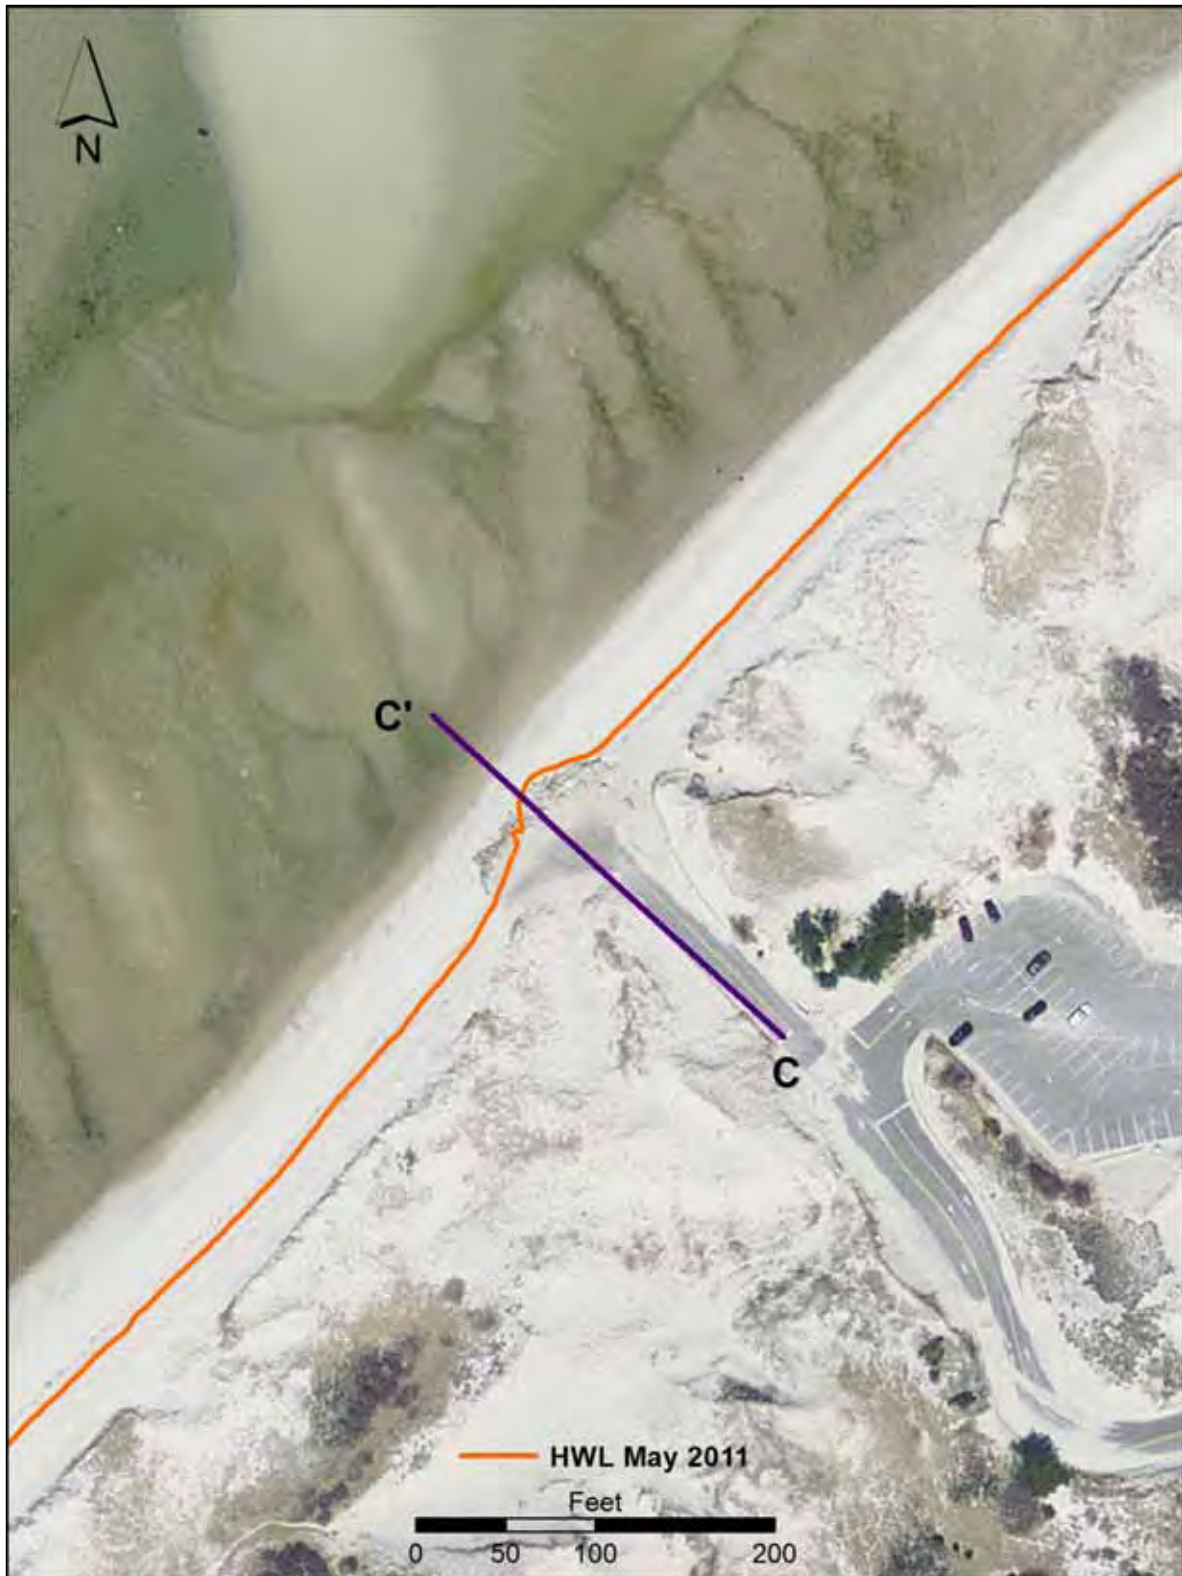
**Figure 15: Location of Beach Transect Measured at the ORV Ramp Leading to Chapin Beach**

A shore-perpendicular transect was surveyed at the ORV ramp to evaluate potential options relative to existing elevations and slopes. The location of this transect is shown in Figure 15, where the position of the observed 2011 high water line is also illustrated. The recent shoreline position indicates that the existing armoring is causing a perturbation in the shoreline and may be causing accelerated beach/dune erosion to the west. In addition, the surveyed transect (Figure 16) indicates that the existing dune height at the location of the ramp is only slightly greater than the 100-year flood zone elevation. To maintain the dune integrity, the roadway elevation should be maintained at this height as the coastal features migrate landward.

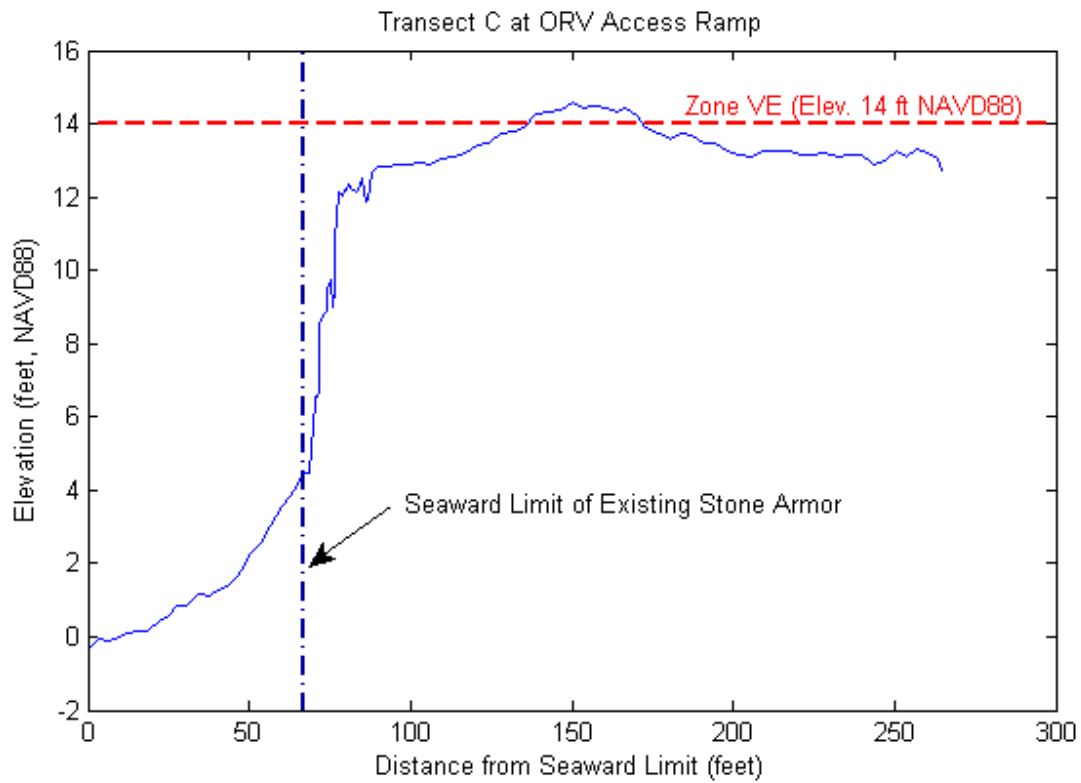
**Figure 16: Beach Transect C for Existing Conditions, Showing the Seaward Limit of the Existing Armor Stone Protecting the ORV Ramp, as well as the Predicted 100-year Flood Zone Elevation**
