West Schoolhouse Preservation

**Application for
Dennis Community Preservation Funds
Calendar Year 2017**

**Submitted by the
Dennis Historical Commission**

7. *Project Title: West Schoolhouse Preservation – Phase II*

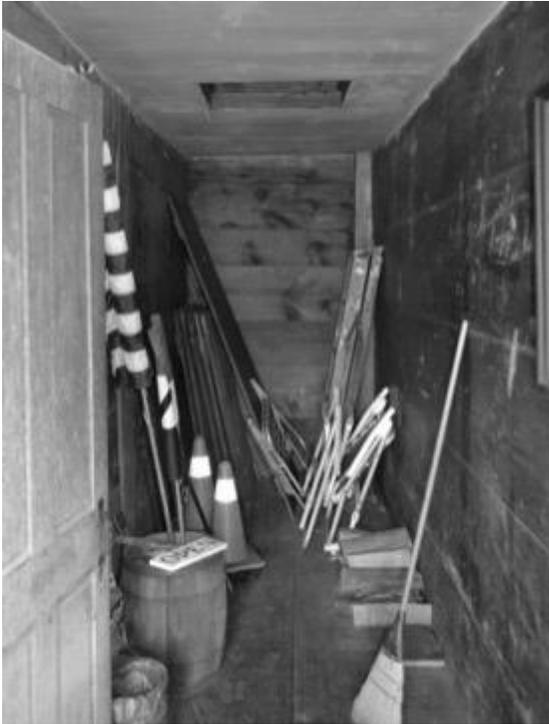
The firebox obviously opened into the large schoolhouse room, meaning that the partition wall between the lobby and the larger school room was situated such that the fireplace

opening was flush with the wall and only the stone or brick hearth projected into the schoolroom beyond the partition wall. The evidence of the roof and ceiling framing indicate that the chimney stack pierced the roof sheathing between two roof rafters and between the east plate and the lowest purlin – a horizontal distance of 31½ inches from plate to joist, and 36 inches between the two rafters. The distance between the east plate and the first ceiling joist to the west, which framed the west side of the chimney stack, was also 31½ inches. This is sufficient space to accommodate a brick firebox and square chimney stack rising above it through the roof. However, this means that the lobby would have been quite narrow. If a board wall forming the west wall of the lobby was built against the west face of the joist overhead, the distance between the surface of the east wall (horizontal boards attached to studs or wainscot and plaster attached to the studs) and the west wall of the lobby would have measured about 38 inches.

The lobby would have been quite narrow and extended only about six feet into the room, ending against the wall enclosing the chimney mass. It likely had a small window in the east wall between the southeast corner post and the chimney mass to provide some light into this space.

The form and finish of the lobby is informed by the surviving lobby of the 1822 Little Red Schoolhouse in Jaffrey Center, NH (photos and information provided by James Garvin). While the lobby of this school does not contain a fireplace and chimney mass, evidence of a fireplace and chimney mass within the lobby space was found in the schoolhouse from Candia, NH, presently exhibited at Old Sturbridge Village.

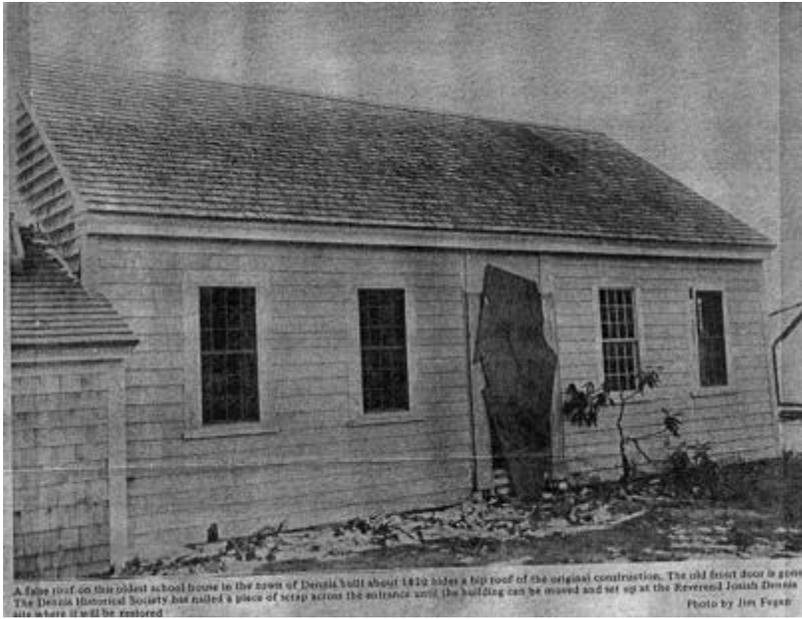
Photo from *Oracle* 25 January 1973 showing building prior to move with gable roof built over the original hipped roof, addition on left gable end.
